SAFETY ALERT

Water tanker rollover at haul road intersection

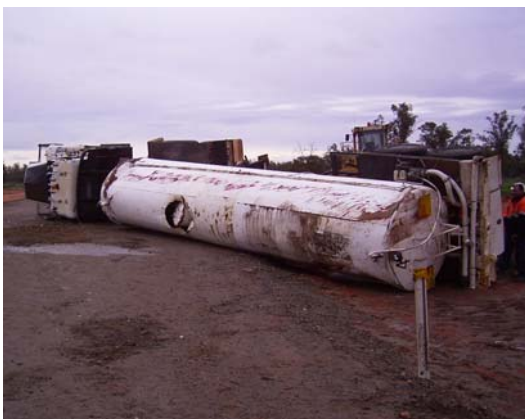
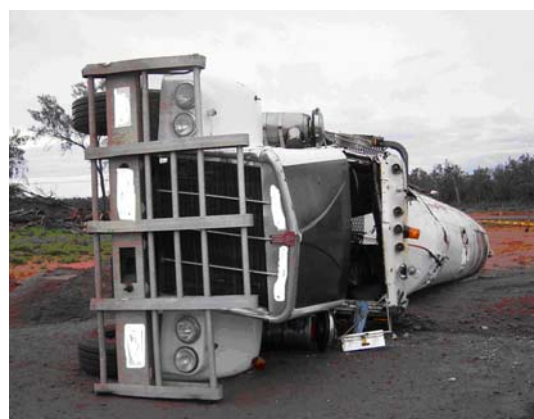
The water tanker came to rest on the wrong side of the haul road with the prime mover in the centre of the road and the rear of the trailer in the table drain at the side of the road.

The investigation could not determine the actual speed of the water tanker before the incident, but given all of the prevailing circumstances it did conclude that the water tanker was travelling too fast to safely negotiate the intersection and that this was the primary contributing factor to the incident.

No baffles were installed in the water tank and a lateral surge of water when the water tanker was attempting to negotiate the intersection may have contributed to the rollover.

- Mines should review their safe work procedures for transporting loads to; ensure that loads are stable, prevent overloading, and assess the requirement for baffles in tanks used for transporting bulk liquids.

- Mines should ensure that haul roads are designed by competent people in accordance with anticipated traffic movements and traffic loading. Safe speed limits should be determined for all haul road situations. Speed limit signs should be clearly visible at all haul road intersections and at other strategic positions where vehicles may converge. Mines should periodically review their haul road design to ensure that it remains appropriate to a changing mine environment.
