SAFETY ALERT

Rock falls from elevated conveyor onto worker's head

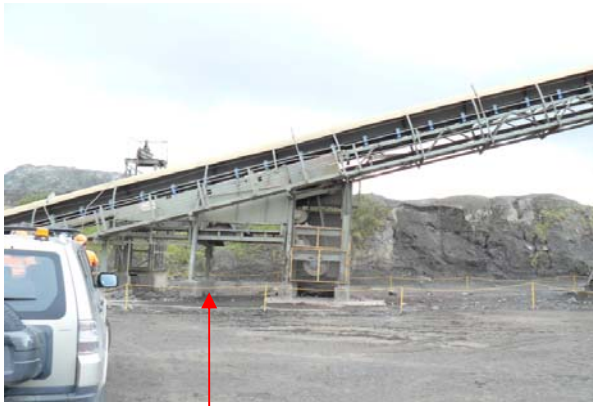
A considerable quantity of rock was observed to be lying on the walkway next to the conveyor, on steel sections of the conveyor structure, on electrical cables and on the ground on both sides of the conveyor for much of the length of the conveyor.

A rock deflection guard had been installed to protect road traffic but this covered only a small area under the conveyor and the deflector was not fitted with sides to prevent rocks deflecting sideways at right angles to the conveyor.

The injured worker was standing in this area when struck by the rock.

1. Assess the potential for material to fall into any accessible area and cause injury, giving due consideration to the height of the fall, maximum speed and weight of the falling material.
2. Where there is any potential for material to fall from a height which may result in injury, take effective means to prevent such injuries.
3. Any area where conveyed materials can accidentally fall or be projected onto persons should be classified as a danger zone and appropriate guards and warning signs must be provided.
4. Consider installing belt tracking limits to prevent belt edge damage and reduce potential for material to spill from the conveyor.
5. Consider maximising the belt troughing angles for elevating conveyors to reduce potential for material to spill.
6. Where practical, take effective steps to prevent localised overload of conveyors which may result in spillage.

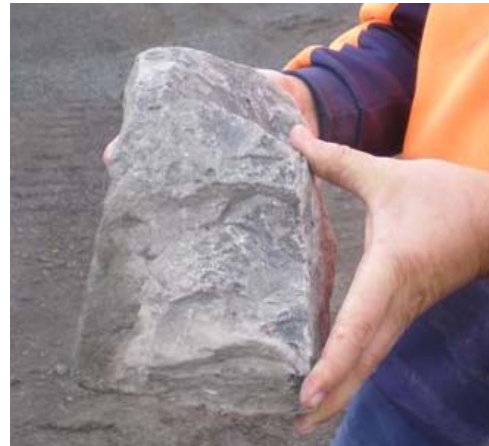
A 10 kilogram rock fell from an overhead elevating conveyor and hit the safety hat of a nearby worker resulting in head injuries, a broken tooth and injury to the area between the worker's head and shoulder.

The rock which struck the worker.
