SAFETY ALERT

Park-brake malfunction leads to crush injuries

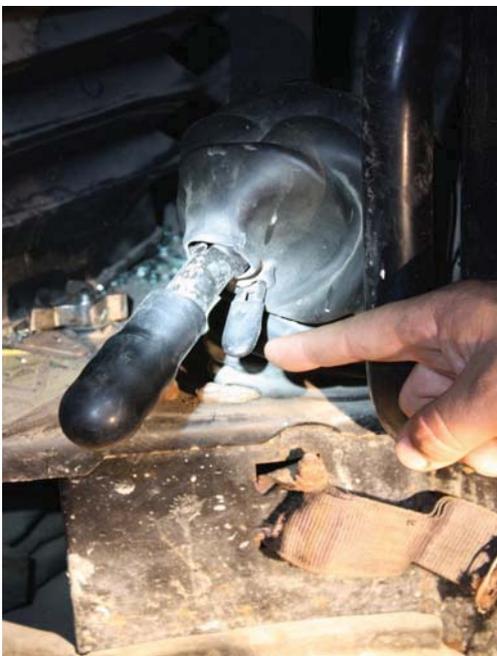
Photo 1.

The telehandler park brake is applied by a lever located to the left of the driver's seat. The park brake is applied when the lever is raised and a tee bar locks the park brake on. A trigger on the lever is used to disengage the tee bar and release the park brake. The park brake assembly is contained within a protective rubber boot (Refer Photo 1).

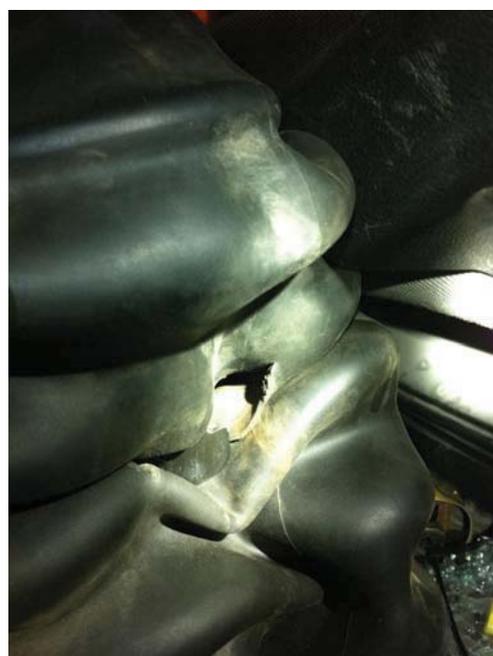
Photo 2.

The investigation determined that the tee bar had worn a hole in the rubber boot (refer Photo 2) and was projecting through the hole when the park brake was applied. The tee bar was prevented from engaging correctly by the torn rubber and while the park brake appeared to be applied it would release if the lever was knocked.

The park brake released when the lever was struck by the driver's self rescuer as he stepped from the cabin of the telehandler.

Mines operating telehandlers or any other mobile plant with park brake mechanisms similar to that described above should immediately inspect and test the park brake for correct operation. If faults are discovered they should be reported to the original equipment manufacturer and should be repaired in accordance with the original equipment manufacturer's recommendations.
