Arc flash injuries received from 22kV ring main unit

Mine Type: All Mine Types

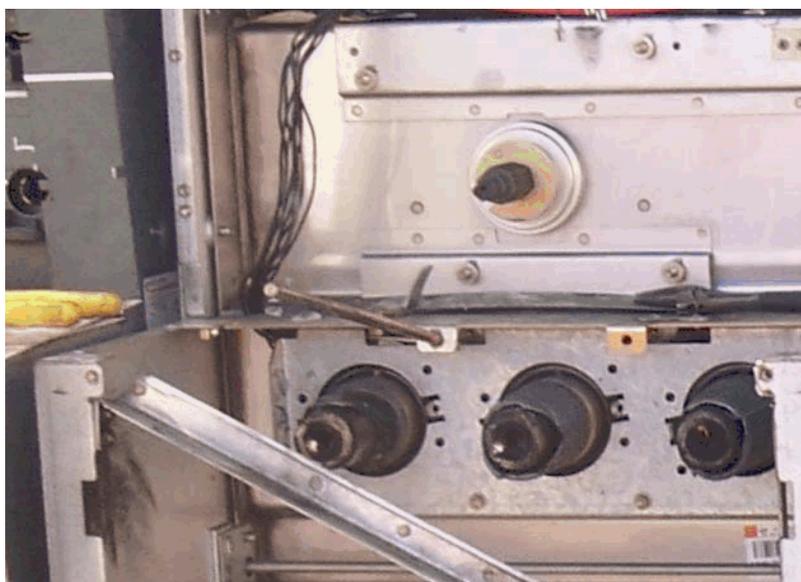
A switching mechanism from a spare RMU was also to be removed for use as a possible replacement. This 22,000 volt RMU can be seen below, with the 3-phase high voltage bushings shown in the lower half of the picture. The switching mechanism has been removed from in front of the hexagonal-shaped operating shaft in the middle top right of the picture. A vertically moving truck located behind this panel connects these three bushings to 'live', 'off', and 'off and earthed' positions, depending on where the operating shaft is positioned. With the truck at the topmost position, the three bushings are disconnected from power and earthed. In the middle position, they are disconnected from power, while in the lowest position, they will be contacting the live 22,000 volt conductors.

When the electrical switching mechanism was removed from this unit, it was de-energised by moving the switching mechanism to the 'off' position, which was then locked in place. However the hexagonal operating shaft was not locked in position and was only held in place by the switching mechanism. The switching mechanism was then removed. As the two electricians were replacing the external covers an arc flash occurred, causing serious burns to both electricians' hands.

Cause: The exact cause of the incident is still under investigation. At this stage, it appears that the high voltage bushings on the RMU were re-energised as the operating shaft rotated and the truck mechanism in the RMU moved under gravity from the 'off' to the 'live' position.

As the electricians were re-assembling the cabinet, it appears an arc flash was initiated by clothing coming in contact with the high voltage terminal, initially creating a phase to phase short circuit.

Comments: The manufacturer's data recommends that prior to energising, check that the connection bushings are fitted with connectors or with insulating caps. This appears to have been overlooked during the testing and commissioning of the equipment.

- All such incidents highlight the importance of switching sheets, access permits and access procedures.
- When performing unfamiliar tasks, a risk assessment is necessary. This should include contacting original equipment manufacturers (OEMs) for guidance and/or procedures if information relating to the task and identification of hazards is not immediately available.
- Inspection and test sheets, commissioning sheets and maintenance check lists must be developed using information supplied in the manufacturer's manuals. This should cover such issues as the insulating caps mentioned in this alert.
