## Rear Dump Truck Drives Over Light Vehicle

**Mine Type:** All Surface Mines

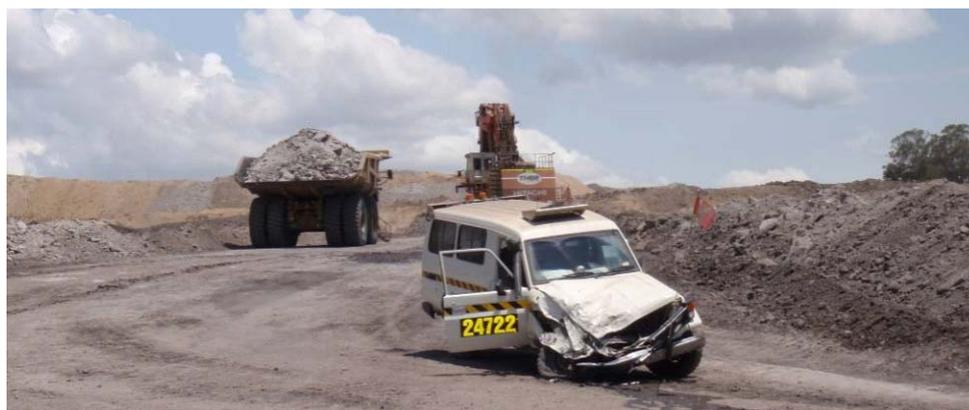
**Incident:** During dayshift, a loaded Cat 785D Rear Dump Truck was travelling off a bench towards the intersection with the ramp leading out of the pit. At the same time, a supervisor was travelling down the ramp in a Toyota Troop Carrier. The supervisor stopped at the intersection to let the truck exit the bench and to turn right onto the ramp. As the truck entered the ramp, the right front wheel (off driver's side) ran over the bonnet of the troop carrier on the driver's side. The truck continued up the ramp and only stopped after the supervisor contacted the truck driver via the two way radio. Nobody was injured in this incident.

- The truck was travelling parallel to the light vehicle prior to the vehicles reaching the intersection. They were separated by the bunding on the ramp which restricted both drivers' visibility.
- The intersection design restricted visibility.
- In exiting the bench, the truck tended to cut the corner due to the difference in grades between the bench and the ramp.
- At a point in the turning arc, the troop carrier was completely hidden behind the 'A' pillar of the truck's cabin.
- The truck driver did not see the light vehicle due to the bunding along the edge of the ramp and warning lights which were ineffective during daylight hours.

- The supervisor may have been distracted whilst testing the radio.

1. Separate light vehicles from heavy vehicles via designated, suitable roads.
2. Review the design of intersections to optimise the field of vision for heavy vehicle operators ensuring:
  - Approaches to the intersections are constructed at a flat grade for a minimum distance of at least the length of the longest vehicle using the intersection.
  - Installation of a median bunding / physical barrier to provide right angle entry to roads and to slow down turning vehicles.
  - Roads at intersections are at 90 degrees to allow for maximum visibility with windrows tapered as intersections are approached.
3. Use proximity detection and collision avoidance technology.
4. Review the effectiveness of the systems used to make light vehicles conspicuous during daylight hours.
5. Provide appropriate signage.
6. Review the effectiveness of communication procedures where vehicles interact.
