# Safety alert

Mines Inspectorate

Safety alert no. 247 (Version 1)  
16 August 2010

## Trucks tipping over the edge

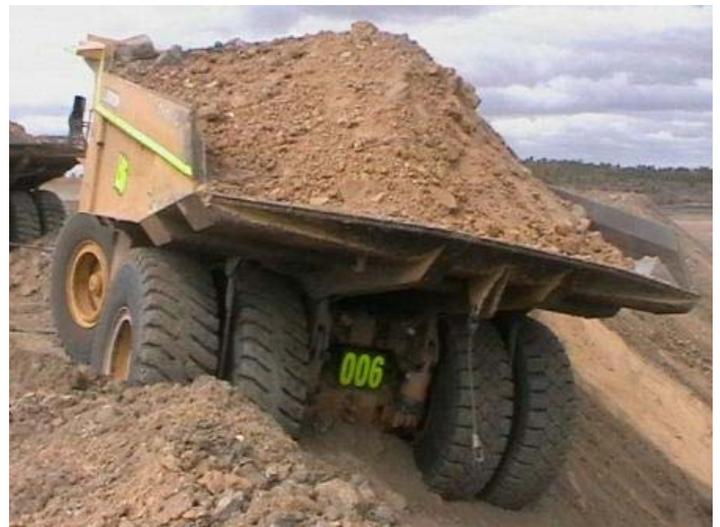
**Incident:** There have been a large number of serious incidents lately involving haul trucks passing through berms when tipping over the edge. In one week recently three events were reported on three consecutive days. Further investigations have also uncovered some mines at which trucks have damaged berms, but the incidents have not been notified to an inspector.

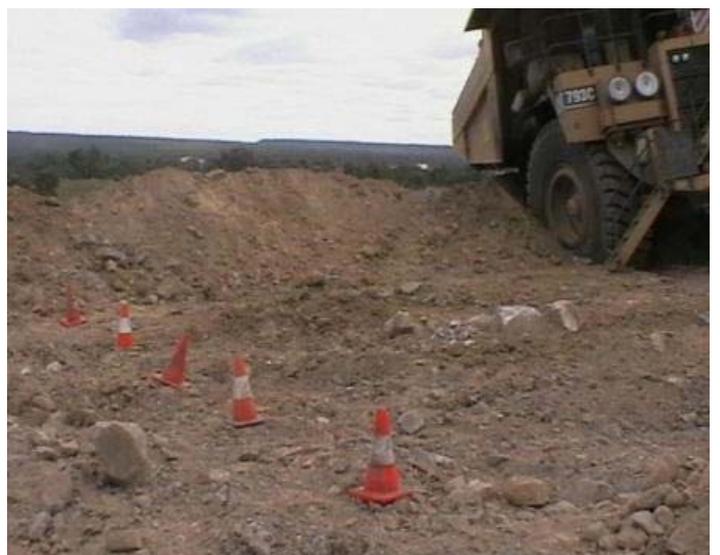
Berms must be seen as a safety extra, and should not be used as a brake or even an indicator that the edge has been reached. They need to be designed to suit the nature of the material and the size of the machinery. While traditional rules of thumb such as half the height of the wheel may be useful, they need to be supported by geotechnical calculations.

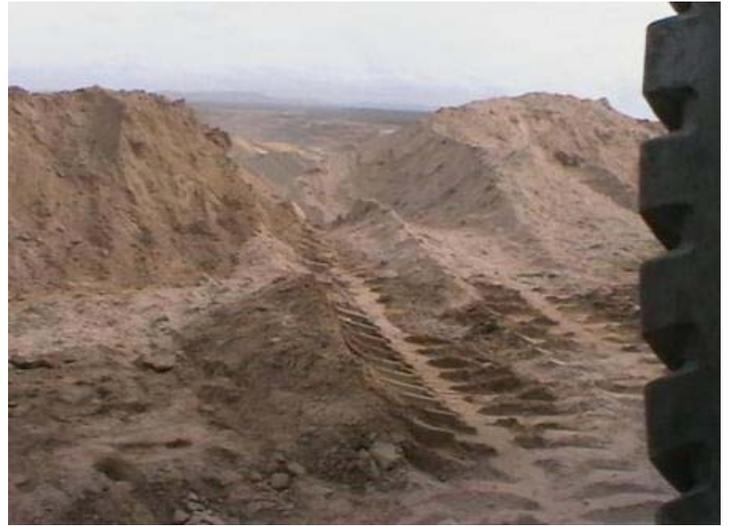
**Angle of approach** - In many of the incidents, the truck has not approached square to the berm, but at an angle of 20 degrees or more. This greatly increases the force exerted on the berm if contact is made.

**Strength of material** - In another incident, the material was a sandy topsoil, which would run through your fingers. A berm made of this material provides no resistance.

Any risk assessment of the effectiveness of berms or the height of dumps would need to consider the nature of the material, among many other things.
