# Safety Alert

Safety Alert No. 283 | 18 January 2012

## Screenbox flywheel failures on Powerscreen® Chieftain 2-deck screening plants

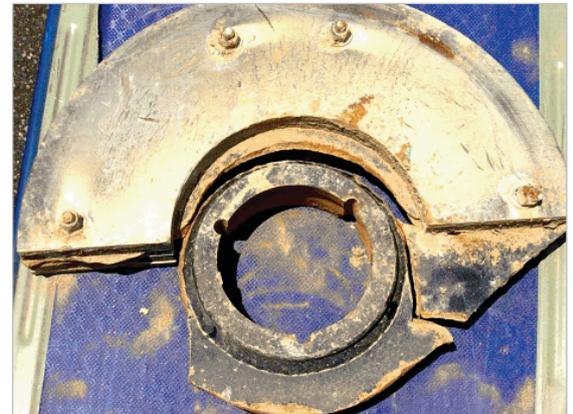
In three separate incidents, the screenbox flywheel on Chieftain 2-deck screening plants failed. Two incidents occurred on a Chieftain 2100 flywheel (damaged flywheel pictured) and one on a Chieftain 1400.

The cause of the failure is yet to be determined but two possibilities are:

- the flywheel was operating outside the design parameters, or
- there was a precondition associated with the welding process.

All three failures exhibited a similar pattern in that the flywheels separated from the hub adjacent to the weld.

The weight of the Chieftain 2100 detached flywheel, with its complement of six counterweights, is in excess of 50 kg. In one incident the disintegrated flywheel landed on the ground underneath the access platform, placing any person in the vicinity at risk. It is not known if the flywheel guard has been designed to contain a disintegrating flywheel.

1. Owners and operators of Powerscreen® Chieftain 2100 and Chieftain 1400 2-deck screening plants should contact Lincom Pacific Equipment Pty Ltd to ascertain what action to take so that injury risk due to a failure of screenbox flywheels is within acceptable limits and as low as reasonably achievable.
2. Keep guards in place while the plant is under operation, testing or fault finding.
3. Ensure workers' safety in the flywheel drop zone should a flywheel fail in service and detach.
