Fatality #18 - October 9, 2008
Falling Material - Nevada - Gold Ore
Newmont USA Limited - South Area

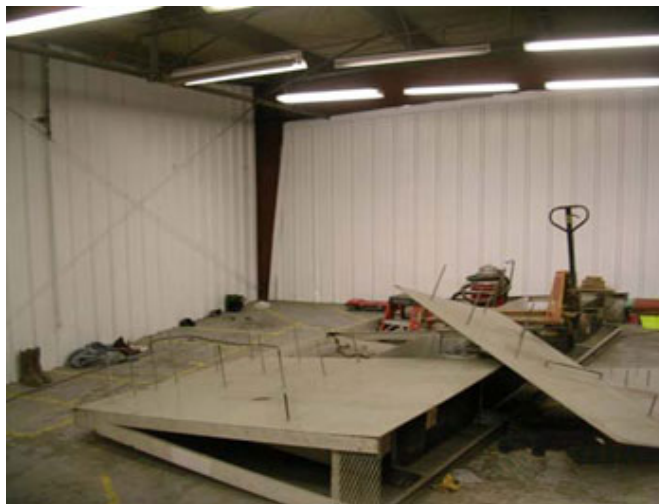
METAL/NONMETAL MINE FATALITY - On October 9, 2008, a 56 year-old welder with 21 years of experience was fatally injured at a surface gold operation. The victim and another miner were dismantling a tool rack in preparation to move it to a new truck shop. Three steel plates (4 feet by 8 feet by ¼ inch) that had been removed from the front section of the tool rack were resting on the shop floor and leaning against the tool rack. The weight of the detached steel plates caused the tool rack to rotate, slide, and topple onto the victim.

- Establish and discuss safe work procedures. Identify and control all hazards to finish the job safely.
- Train all persons to recognize and understand safe job procedures before beginning work.
- Evaluate procedures to ensure all possible hazards have been identified and appropriate controls are in place to protect persons.
- Continually check for unstable conditions throughout the dismantling process.
- Secure or remove heavy objects that have the potential to suddenly or unexpectedly shift.
