Mines Safety Significant Incident Report No. 162

Fitter struck by roller shutter support bracket

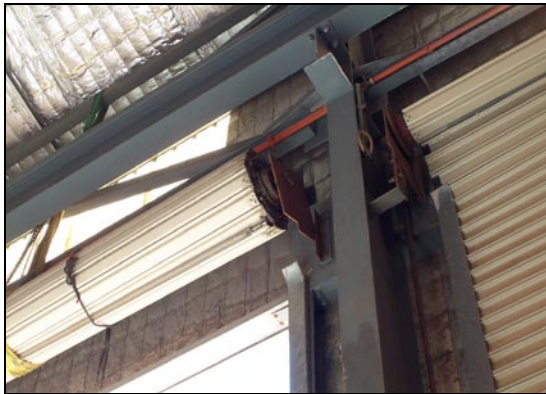
View of non-drive end of roller shutter

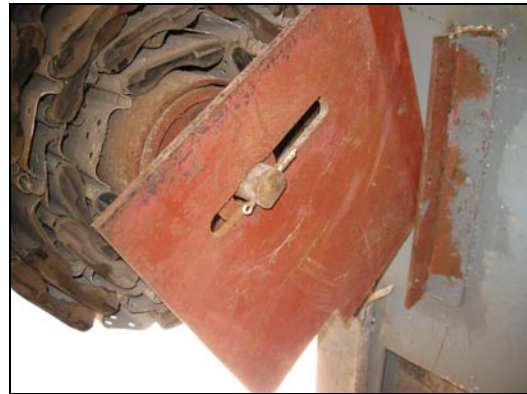
Close-up view of support bracket after incident

When the fitter removed the final bolt from the support bracket on the non-drive end, the bracket spun and struck the fitter in the head. The fitter was wearing a safety helmet and safety glasses. The glasses were hit by the bracket and may have mitigated the extent of the injuries sustained by the fitter.

- The bracket rotated suddenly due to the release of stored spring (mechanical) energy upon removal of the last bolt from the support bracket.
- Before undertaking the task, work permits were issued based on a task hazard analysis. The hazard of electrical energy was recognized by the work team and appropriate electrical isolation performed. However, the work team, including supervisory personnel, failed to identify the hazard of stored mechanical energy.
- No signage was available warning personnel of the hazard.
- The task of removing the roller shutter was non-routine.
- Personnel in the work team had not performed this specific task before, nor were they formally trained or instructed in the task.

- Develop and implement procedures for the installation, maintenance and removal of roller shutters on site, based on a risk assessment and the manufacturer's instructions.
- Persons performing work on roller shutters must be suitably experienced, trained and competent to perform the task.
- Ensure that the site change management processes are effective in identifying tasks that are non-routine.
- Responsible persons should conduct an on-site audit of plant with stored energy hazards and assess the adequacy of control measures.
- Install warning signage on roller shutters and other installations to identify the hazard of stored mechanical energy.
- Consider installing later model roller shutters with improved engineering controls to minimise the risk of stored mechanical energy to personnel.
