LAND DAMAGE ASSESSMENT LIQUEFACTION & LATERAL SPREAD

**Presented by Murray Discombe
Fraser Thomas Ltd, Auckland
at the Annual QuarryNZ Conference
Wellington, New Zealand
July 2012**

Land Damage Assessment

Liquefaction & Lateral Spread

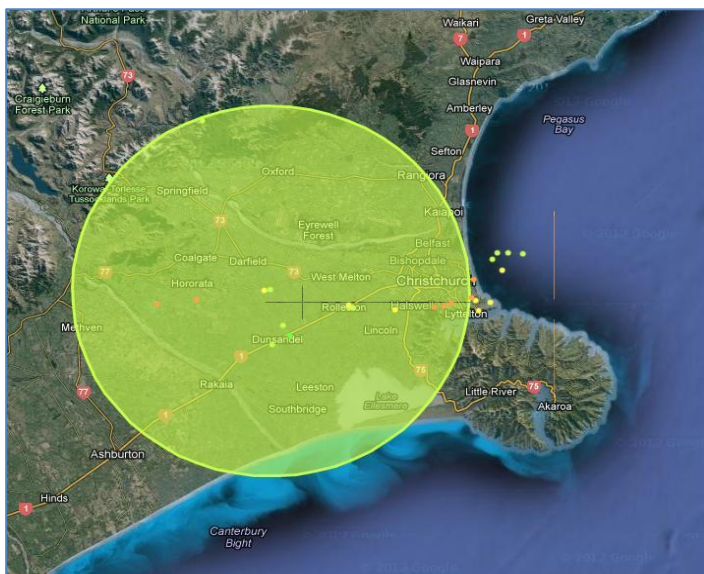
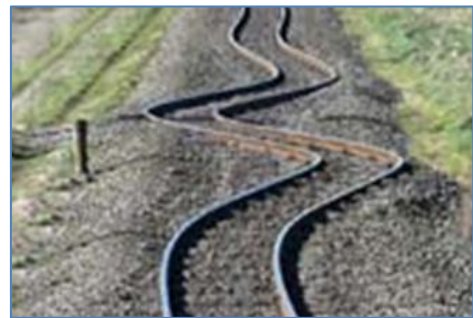
The first earthquake on 4th September 2010 centered near Darfield measured 7.1 on the Richter scale and caused unbelievable damage. The distorted railway line above is a good example of its power.

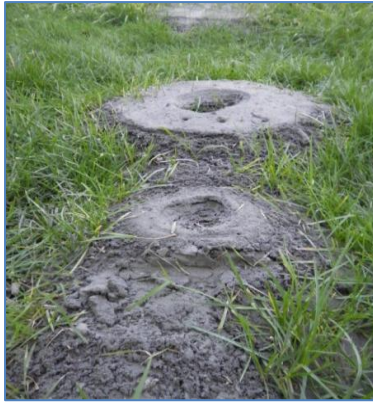
A row of sand boils look like mini volcanoes.

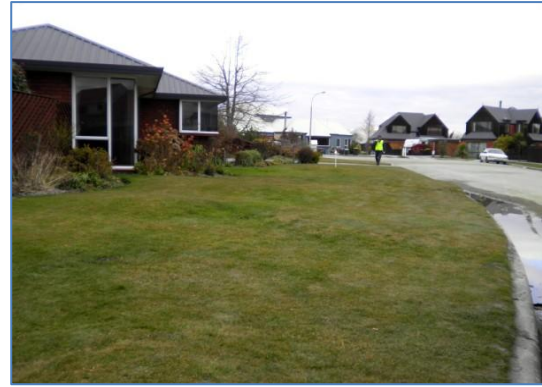
Sand boils created huge undulations in this lawn.

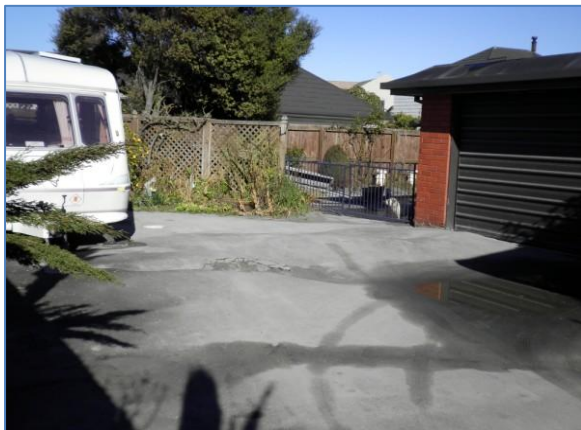
Sand boils – deformation of asphalt driveway.

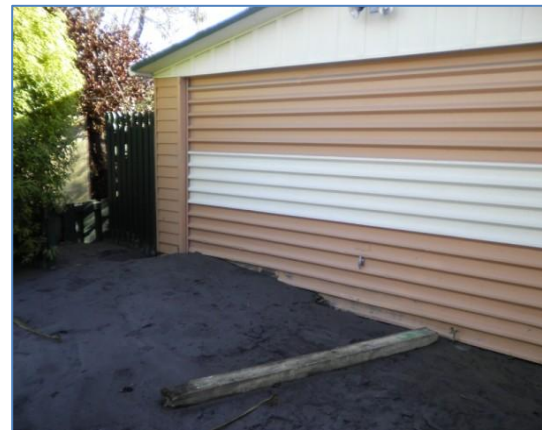
Liquefaction, the aftermath is often a heavy densely-packed fine charcoal coloured silty sand.

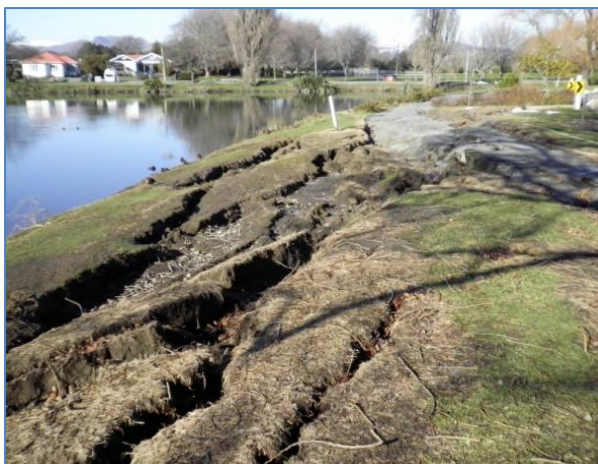
Lateral spreading fissures near the Avon River.

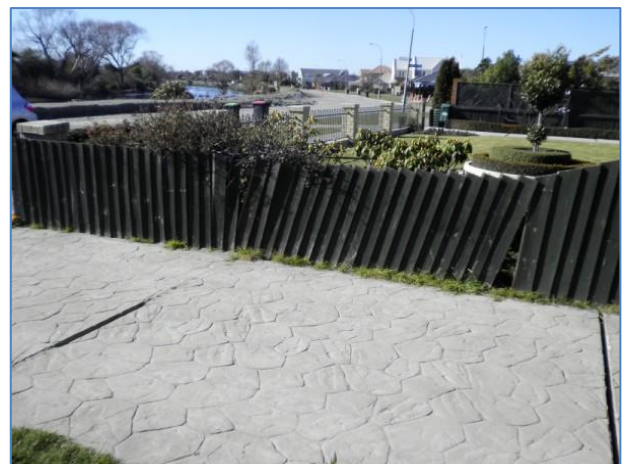
Deformed fences are good indicators of ground movement associated with lateral spread.

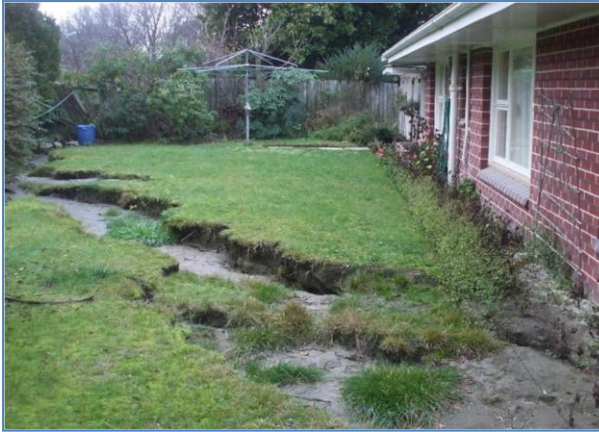
A 0.9m wide “river” of sand through this property shows the magnitude of lateral spread.

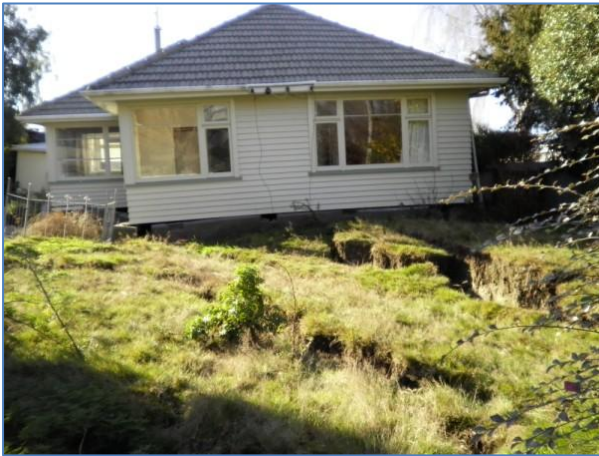
Land damage associated with lateral spread has caused severe tilt in this dwelling located just 20m from the Avon River.

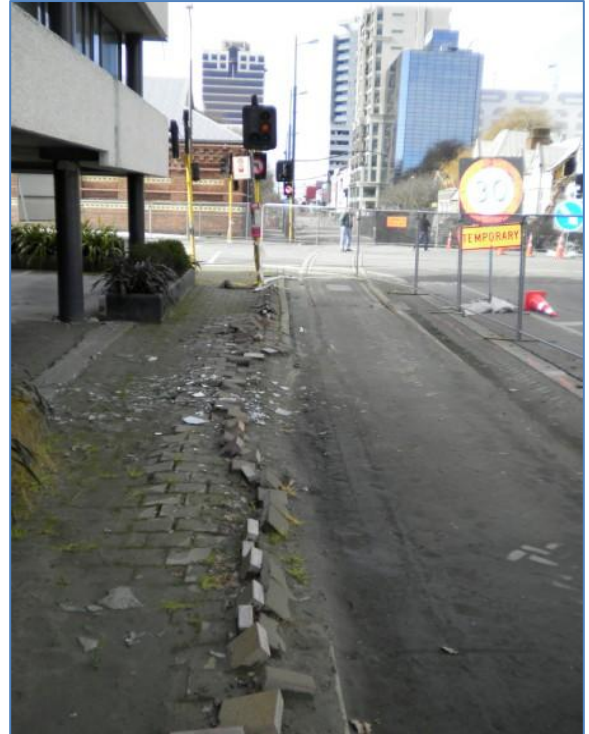
In the central city a distorted row of cobbles denotes lateral spread coupled with severe shaking damage.

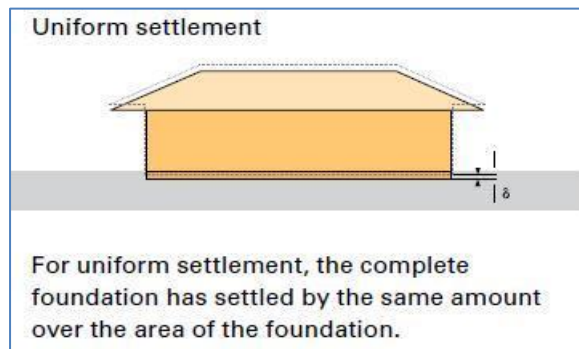
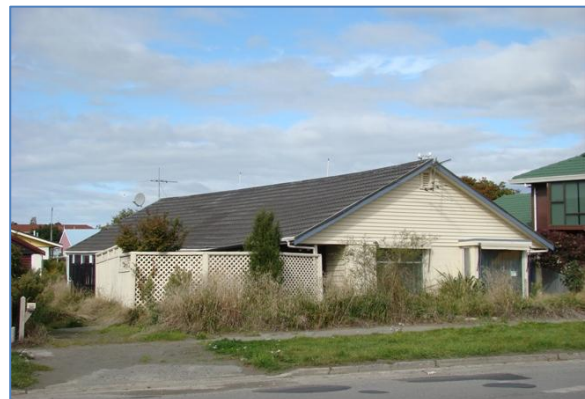
In this example, the house has settled approx 550mm.

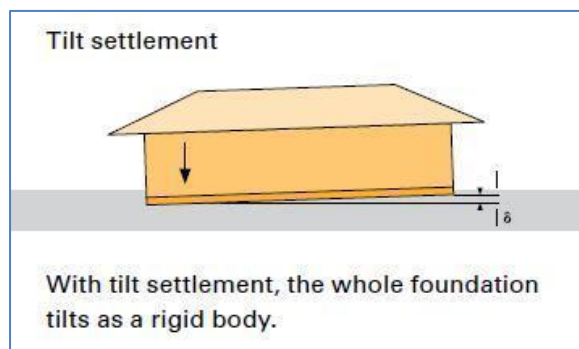
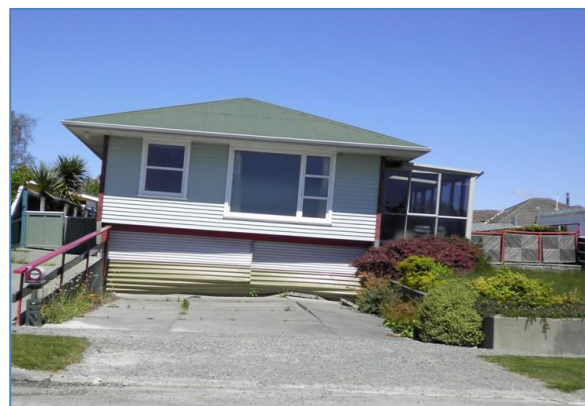
I have seen many examples of tilt settlement but this one depicts it best.

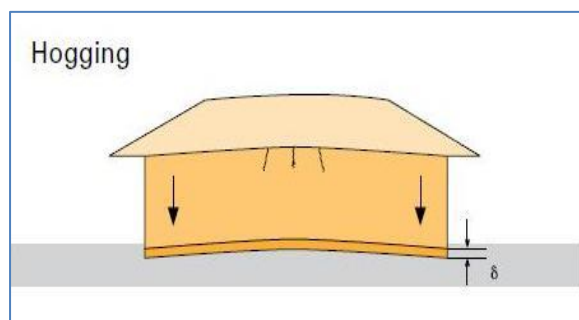
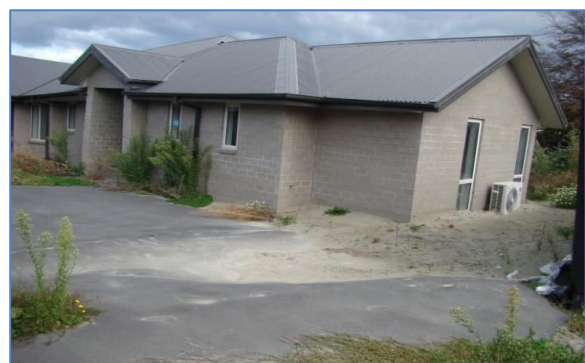
Hogging - one end of this dwelling slumped more than 650mm.

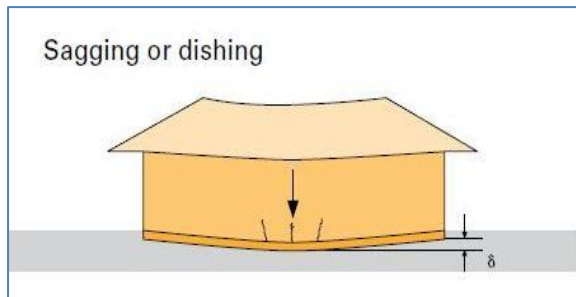
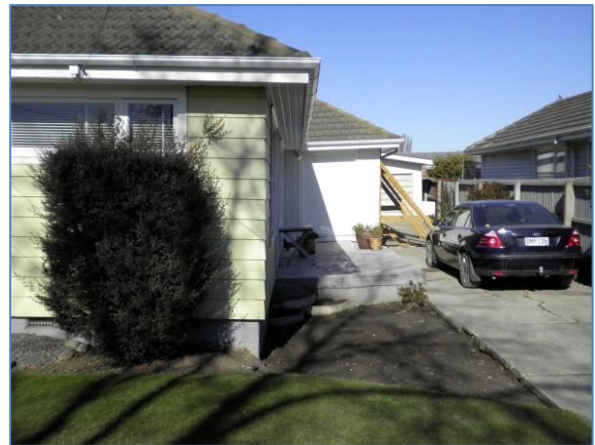
Here the foundations of this 'L-shaped' dwelling have collapsed causing it to sag.

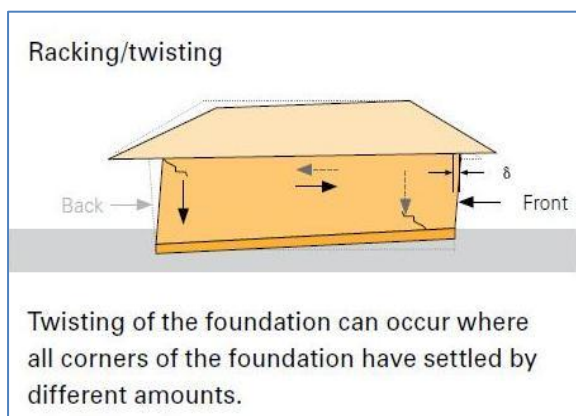
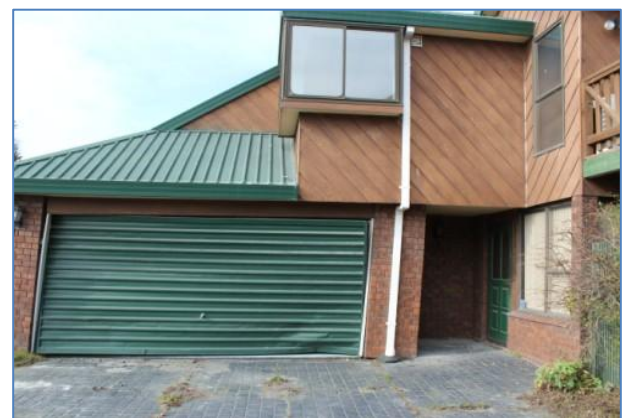
This dwelling was 'red stickered' due to significant racking and twisting.

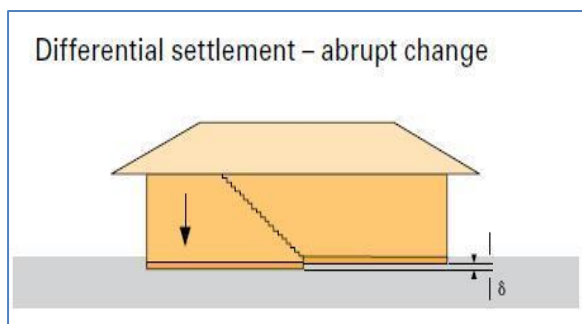
In this type of differential settlement one portion of the foundation is lower than an adjacent section.

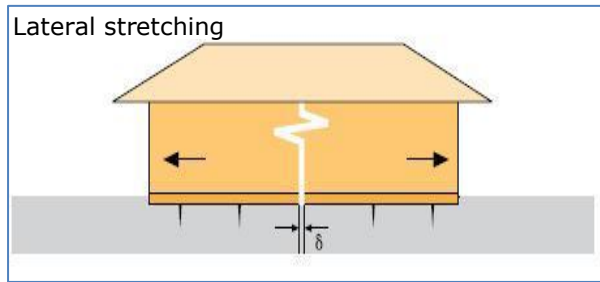
Lateral stretching is almost always associated with lateral spreading.

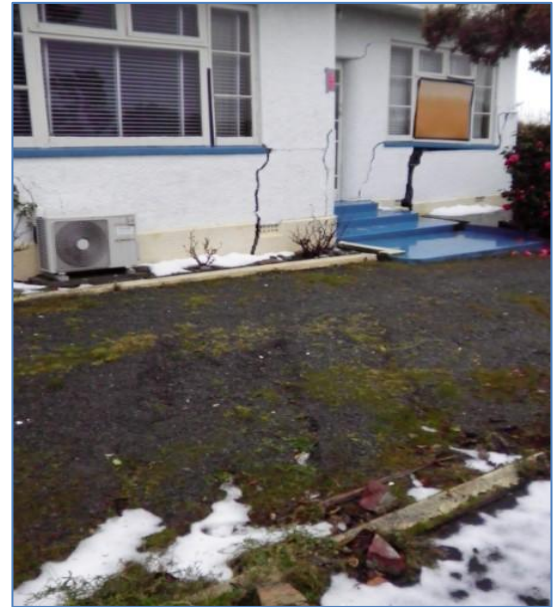
This stucco dwelling located just 30m from the Avon River has several rooms torn apart – induced by the lateral spread cracks directly through the surrounding ground.

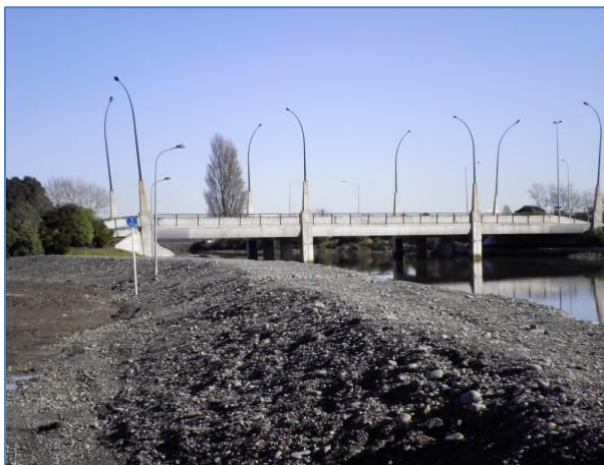
Street lights located at each end of the bridge are attached to the abutments. The base of the abutments has slid towards the river as indicated by the angle of the lights - 4 to 5 degrees tilt.

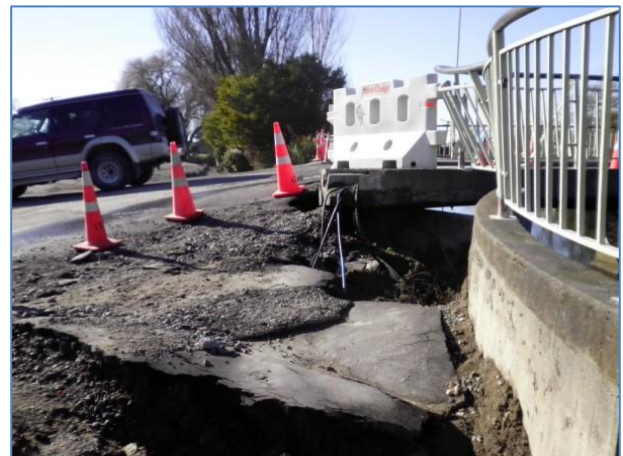
This photo demonstrates the power of earthquake - significant misalignment of bridge and abutment.

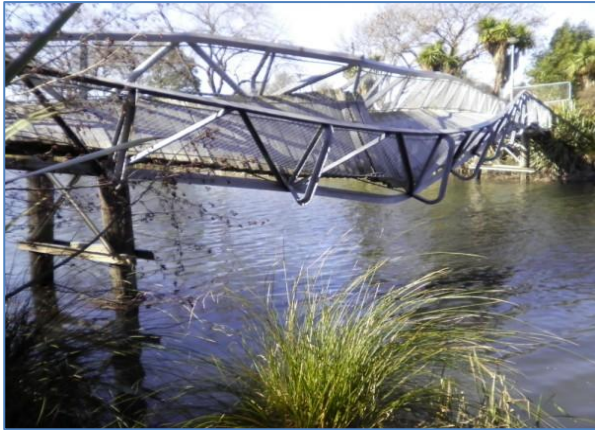
The entire Medway pedestrian bridge has been severely distorted when the west bank moved approx 1.3m relative to east bank.

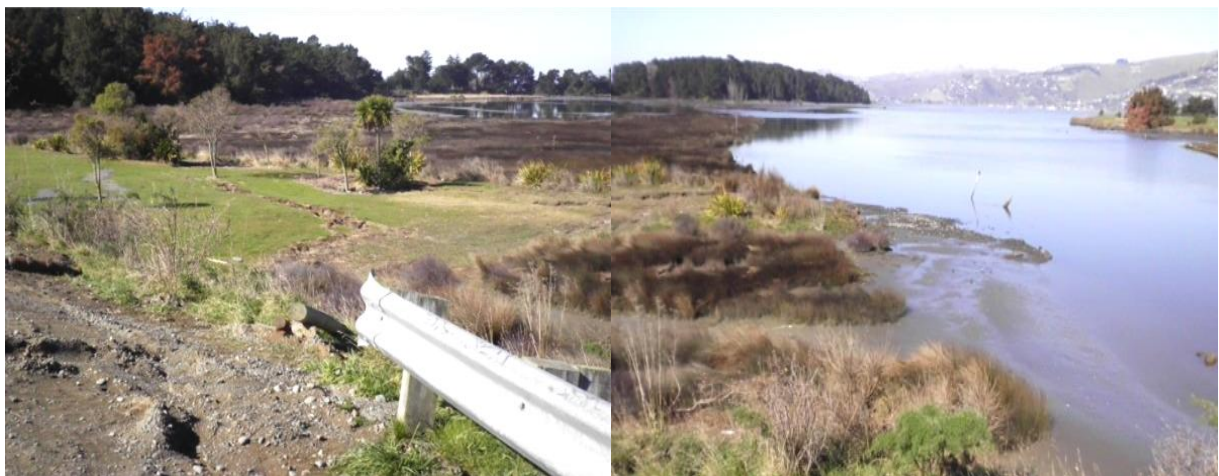
Lateral spread fissures parallel to the estuary edge (shown in the above photos) severely impacted on the bridge abutments to the bridge crossing the mouth of the Avon River. The bridge is now closed to all traffic waiting on full engineering assessment and repair.

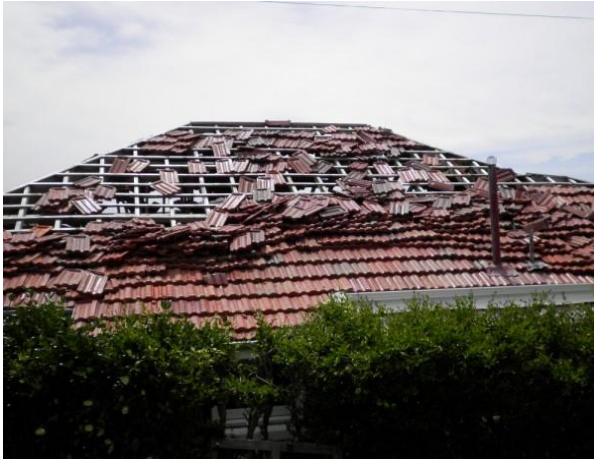
Dislodged roof tiles.

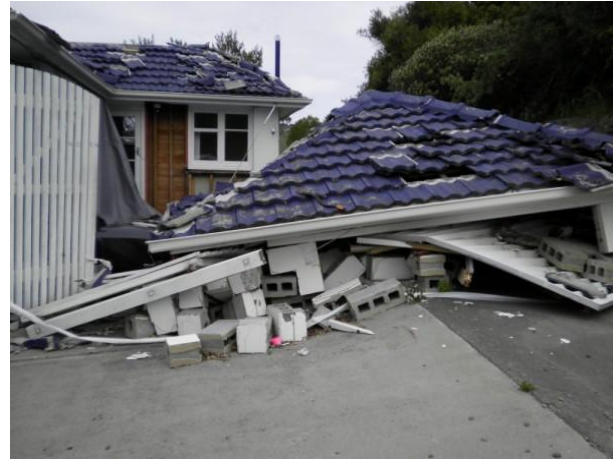
This house has been severely damaged, the garage totally destroyed (a good example of unreinforced masonry!).

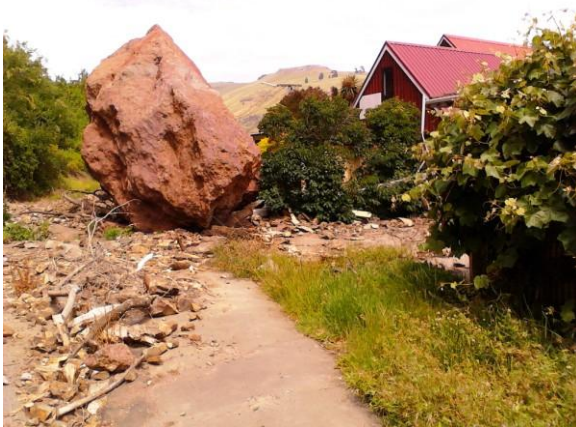
This rock completely flattened a street light pole and came to rest on the footpath in front of this dwelling.

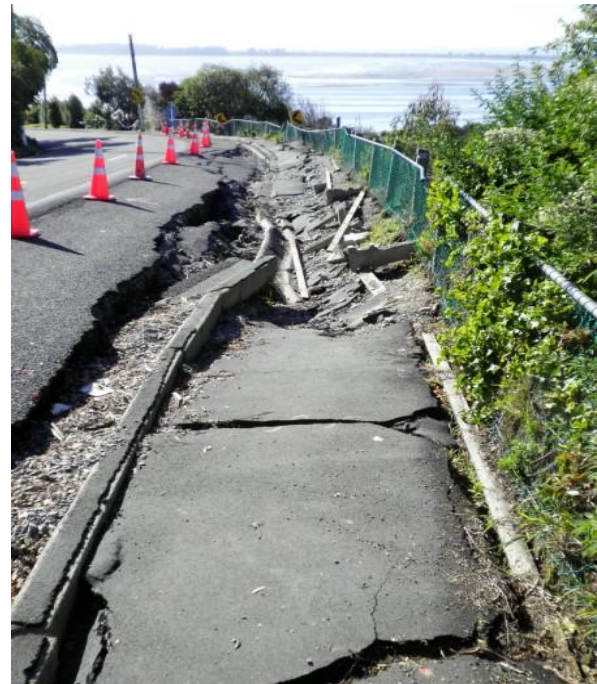
Tension cracks trigger road shoulder collapse and potential landslide.
