Fires on Mine Sites

Background

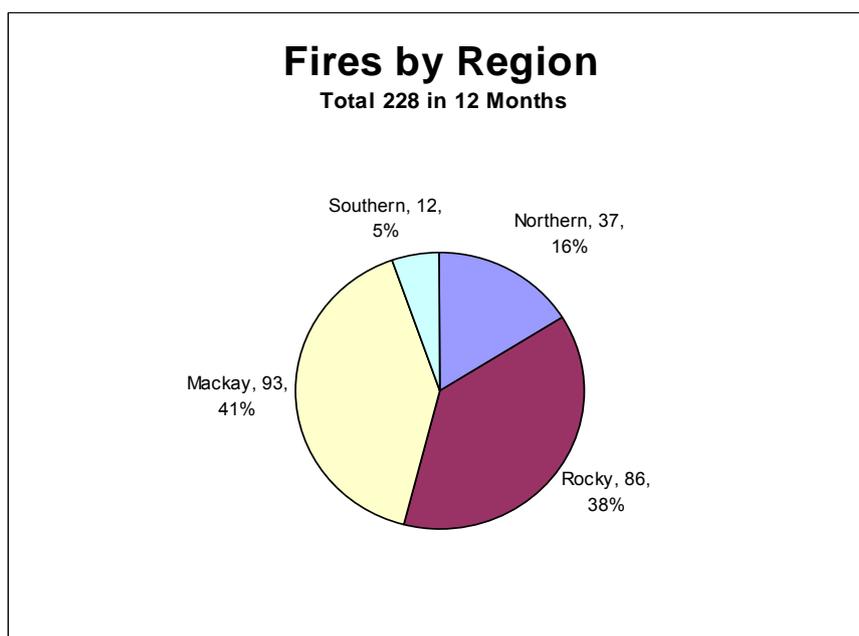
The first diagram shows where fires were occurring in the Department of Mines and Energy Regions. (Central Region has been broken up into Rockhampton and Mackay, for obvious reasons.) It reports on the:

- number of fires on a vehicle or plant, and
- number of fires that have endangered the safety or health of a person.

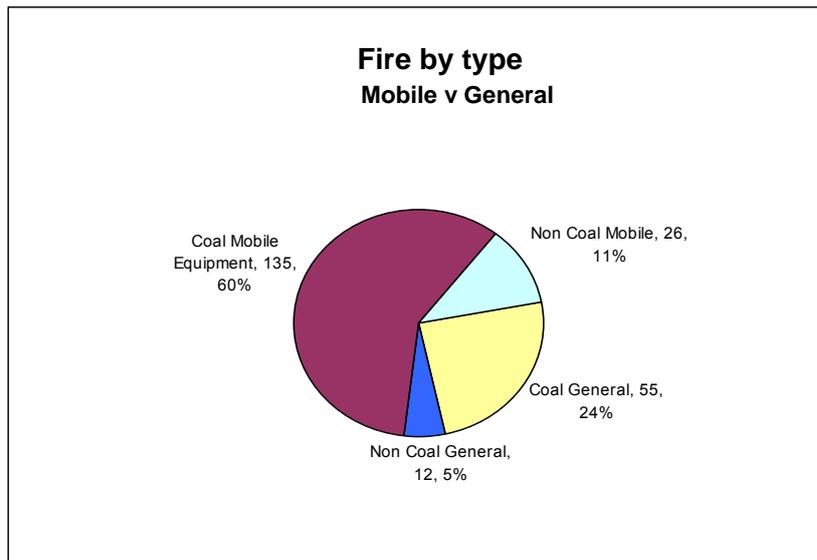
The second diagram below shows the same data split four ways into:

- coal mining
- non-coal mining
- those specifically on mobile equipment
- general fires, such as
 - material handling, specifically belt conveying
 - process and coal preparation plants
 - cutting and welding incidents
 - any reported fire that did not have a stated mobile equipment involvement.

It is clear that coal mines and mobile equipment account for the vast majority of the fires.

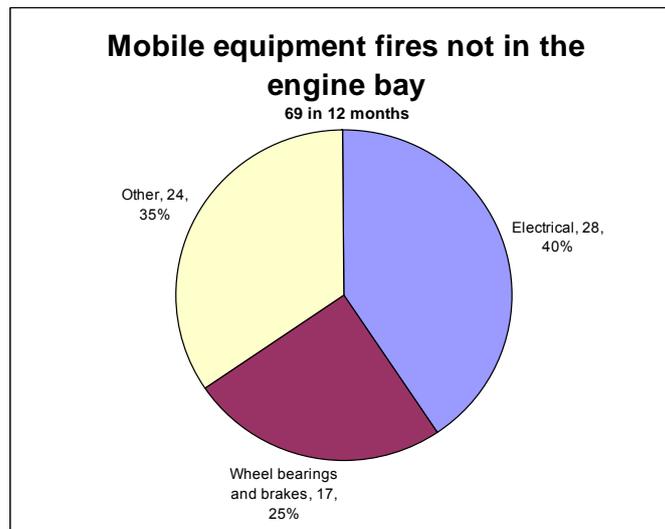
The third diagram shows the 69 fires which occurred on mobile equipment but not in the engine bay.

The 28 fires reported as having an electrical source included:

- alternator
- starter motor jammed
- overheated cables
- cables shorted due to burnt insulation (engine hot surface).

Twenty-four fires were from a myriad of causes including:

- steering hose blown
- frictional heat from rubbing against moving part
- fires that did not have a cause stated in the report.

The remaining 17 fires were wheel bearings (mainly on road style haulage trucks and trailers) and brakes (heavy transport float).

Improved inspection and maintenance of the mobile equipment would have detected and removed many of these 'elsewhere on the vehicle' sources and prevented the fire from occurring.

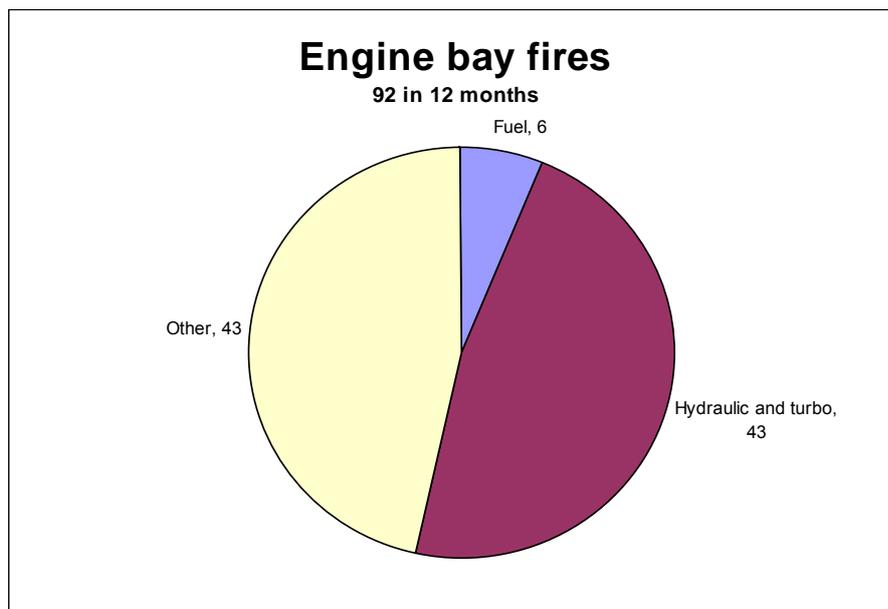
In diagram four below, of the 92 fires in the engine bay, the turbocharger was mentioned in 43 cases. Consistently reported were 'hose failed and sprayed oil onto the turbo charger' or 'the turbo charger failed causing a fire from the resultant cooling oil leak'.

It would be expected that diesel fuel fires would predominate in an analysis of engine bay fires but diesel fuel from cracked or leaking fuel lines was remarkably low in occurrence. This is testament to the modification work done by equipment manufacturers in answer to a similar rise in engine bay fires almost a decade ago.

The 'other' category, also with 43 fires, indicates poor maintenance practices and includes such things as:

- rag and flammable material left in the engine well
- rag fell onto hot engine
- fuel or oil spilled by fitter onto hot engine
- loose oil and fuel filter housing.

All of these could be controlled with increased vigilance and care of maintenance personnel.

Quality maintenance practices are required to control these hazards and prevent the all-too-common occurrence of fire. Very few reported fires in the engine bay have resulted in any change to fire control, the fires will continue as long as there are no positive controls put in place.

Routine replacement of hoses before imminent failure, routine change out of critical components, such as the turbocharger, are just two of the preventative measures that are well-known, easily achieved but rarely feature in mines maintenance practices. Spending less on maintenance is not a viable cost-cutting strategy. The pain of poor maintenance will last long after the pleasure of cost cutting.
