SAFETY ALERT

Driver injured in dump truck rollover

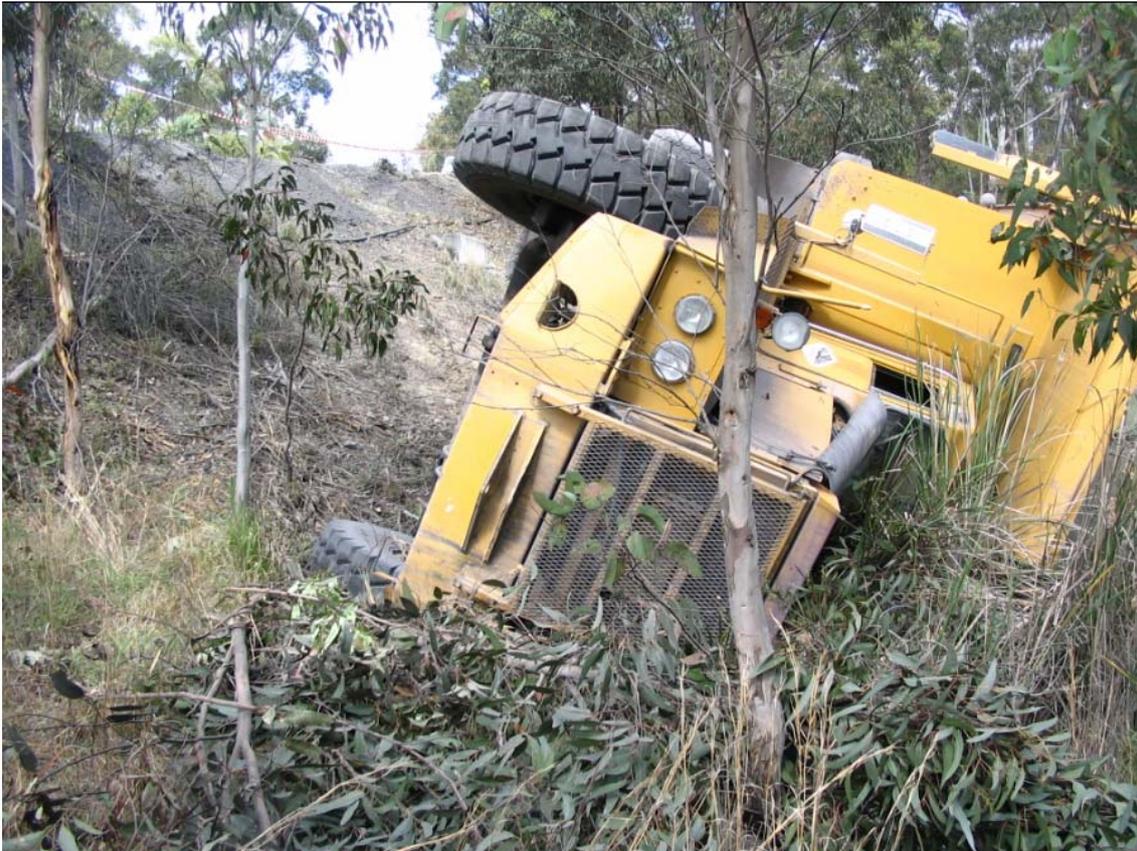
The driver of a dump truck lost control while travelling down a hill, failed to negotiate a bend in the road, rolled down an embankment and came to rest on the edge of a dam. He suffered severe injuries as a result of the incident.

It appears the driver tried to change gears while travelling down the grade and while the exhaust brake was engaged. The engine stalled when the transmission was not engaged, so the drive wheels were no longer causing the engine to rotate. As a result, engine braking was lost. Once stalled, he could not put the transmission back into gear to slow the truck.

As a result of the engine stalling, the hydraulic power supply for the steering was lost. The driver was unable to steer the truck around the bend at the bottom of the grade. It appears the driver tried to use the service brake, but it failed to stop the vehicle before the bend.

The truck was not provided with any form of emergency steering.

A device to prevent the exhaust brake system from reducing the engine speed down to stall speed had not been installed.

The haul road did not have any safety windrows or barriers.

The dump truck lying on its side after rolling over an embankment.

1. Provide emergency steering to enable equipment to be brought safely to rest in the event of engine or power failure. Give preference to a system which will cut in automatically and warn the driver when the main system fails. Refer to *MDG 15 Guideline for mobile and transportable equipment for use in mines* for further guidance.
2. Review the effectiveness and limitations of the various braking systems during both normal and abnormal circumstances, utilising the following principles:
 - The service brakes should be capable of stopping the maximum load on the maximum grade at the maximum speed
 - The emergency brakes should be capable of stopping the maximum load on the maximum grade at the maximum speed

- Retardation systems should not be able to cause the engine to stall. For engine compression braking systems, this may be achieved by a device which senses engine speed and automatically takes corrective actions if the speed drops to a recommended minimum. This device should be in addition to any device which disconnects the retardation system when the clutch is depressed

6. Review the operation of the Defect Management System.
 7. Provide safety windrows or other barriers along haul roads wherever a significant risk of a vehicle rolling over, falling down a significant drop or coming to rest with significant impact is present.
