SAFETY ALERT

Structural failure and collapse of drill rig mast

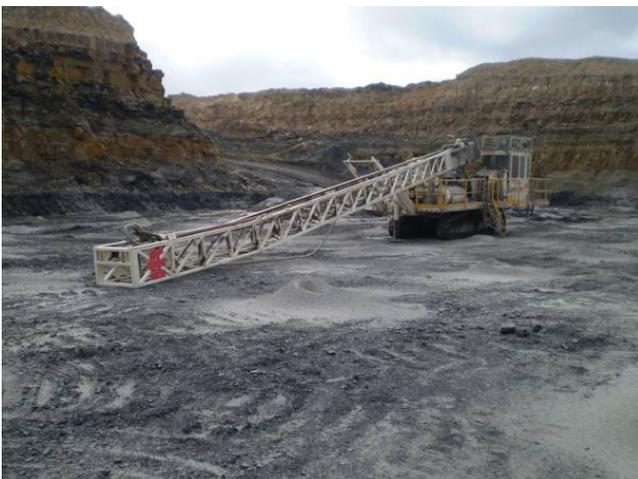
The operator was attempting to lower the mast on a single pass over-burden drill rig before tramming off the bench and up the access ramp. The operator had unlocked the mast locking pins and was lowering the mast when the lower pivot points on the mast failed, causing it to collapse. The drill sustained substantial damage but there were no recorded injuries.

The collapsed drill rig mast (left) and the drill rig's failed pivot point (right) on the RHS tubing.

1. Include, as part of the operator's pre-operational checks, a visual inspection of the mast pivot points, pivot shaft and supporting structure for any visual signs of cracking or component failure.

2. Include more detailed visual inspections on all critical elements as part of all periodic maintenance checks.
3. Consult with the plant original equipment manufacturer (OEM) about the frequency of non-destructive testing (NDT) of all critical structural elements to include, but not be limited to, mast pivot points, pivot shafts, locking devices and supporting structures.

5. Develop 'exclusion zones' around the plant whenever the mast is being raised or lowered before tramming or servicing.
6. Consult with the plant OEM to ensure the mast pivot points, pivot shaft and supporting structure are of the latest design. Should the plant require modification, this should be carried out in consultation with the plant OEM.

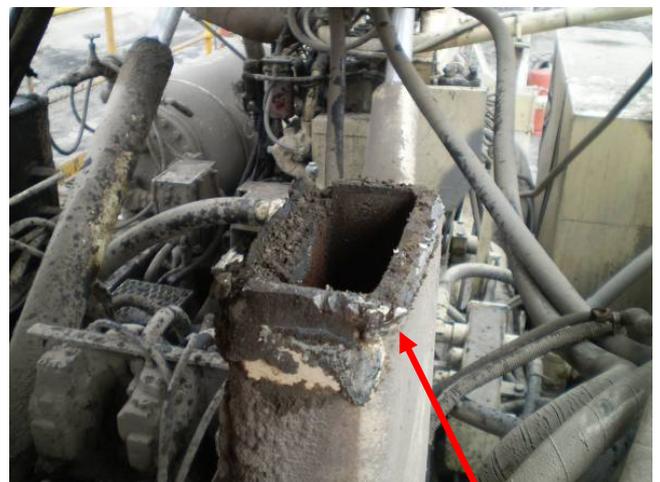
An onsite inspection concluded that the mast pivot points had failed where the bearing blocks were welded onto two RHS (rectangular hollow support) vertical supports. Further visual inspection of the drill rig identified additional cracking at the base of the bearing block support steel work.

7. Where modifications have been made, or are required to be made, ensure design changes are assessed by the plant OEM or a suitably qualified person.
