# SAFETY BULLETIN

## Human interaction with backhoes and excavators

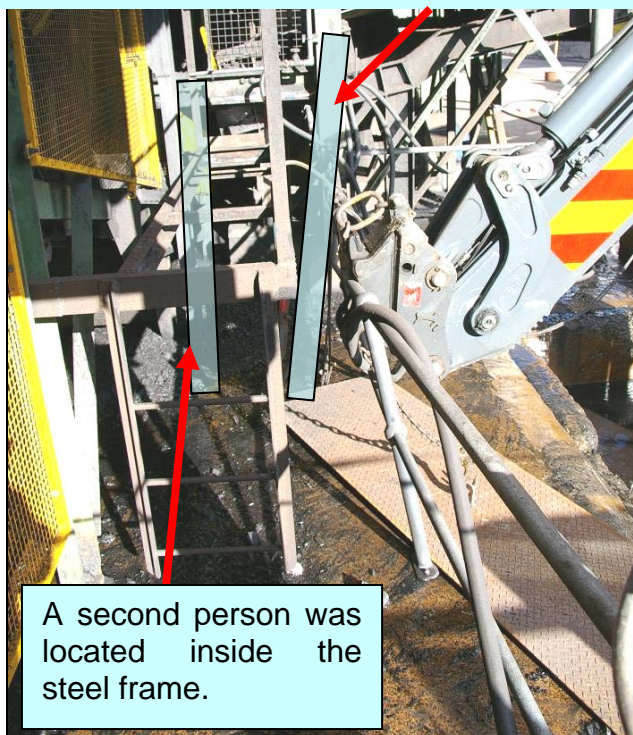
Injured person had entered into the work zone and was positioned between two steel structures. The person was crushed between the railing forced by the backhoe arm and the fixed steel structure. The backhoe operator was not aware of the location of the injured person due to the raised backhoe arm.

- a. Remove the offsider from the work zone of an excavator or backhoe.
- b. Place hard barrier controls to prevent an offsider from entering the work zone without the machine operator being fully aware of the intent to enter.

- a. When handling pipes and logs provide guarding for cabin windows.
- b. Proximity detection to warn the machine operator of persons and equipment around machines has been trialled at several NSW and Queensland mining operations. It is reasonably practicable to use proximity detection technology to warn an operator of the unintended presence of a person in the work zone of a backhoe or excavator.

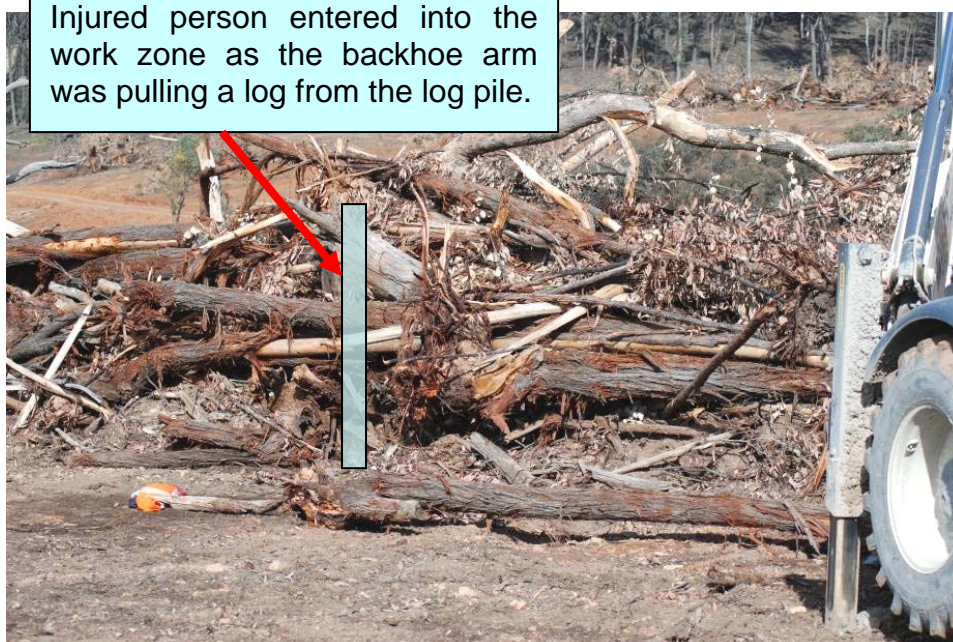
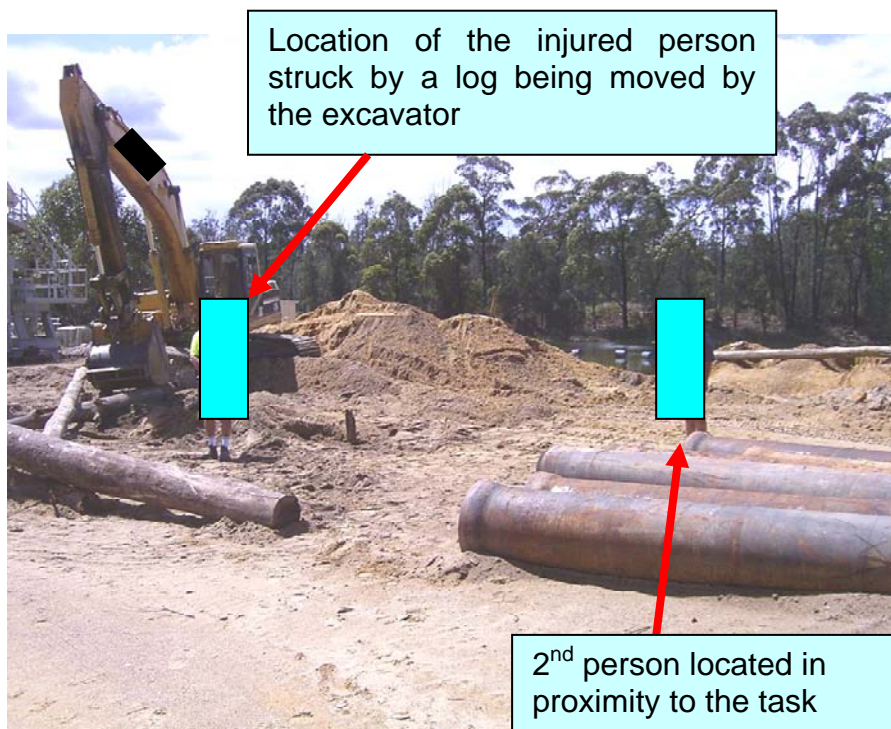
Injured person entered into the work zone as the backhoe arm was pulling a log from the log pile.

- a. Substitute the method of controlling the load instead of reliance on hands-on human interaction with the load, e.g. use tag lines.
- b. Substitute the risk in consultation with engineering advice to ensure lifting and pulling equipment is used within its rated capacity.
- c. Substitute in consultation with the appropriate OEM fit-for-purpose equipment suitable for the task, e.g. use of log grab and pipe handling devices.

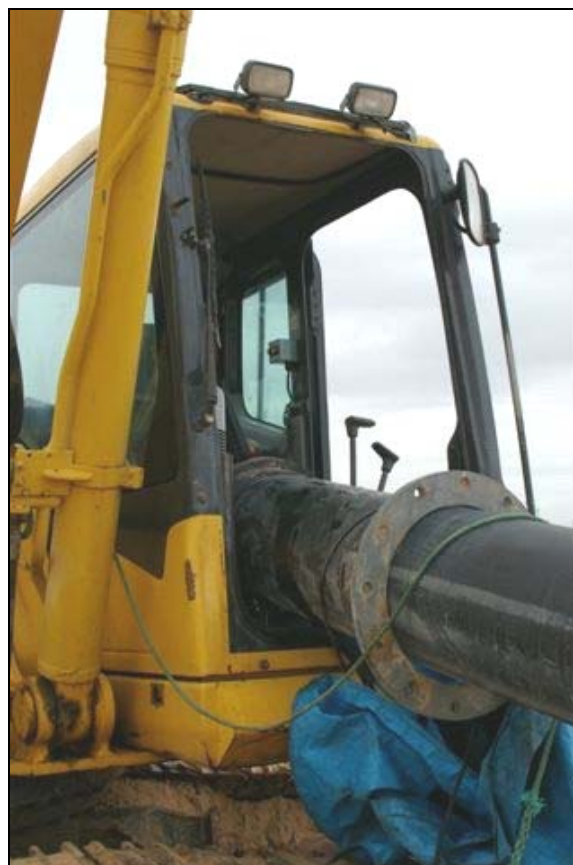
The following photograph was taken following an incident involving lifting and dragging a 12 metre length of polyethylene pipe weighing approximately 600kg by an excavator. The pipe slipped through the supporting chains and entered the operator's cabin, striking the operator and resulting in injury.
