## Bulldozer Brake Failure

### INCIDENT

A forestry worker was killed when the Caterpillar Model 527 bulldozer he was operating rolled over a track when the foot brake linkage failed.

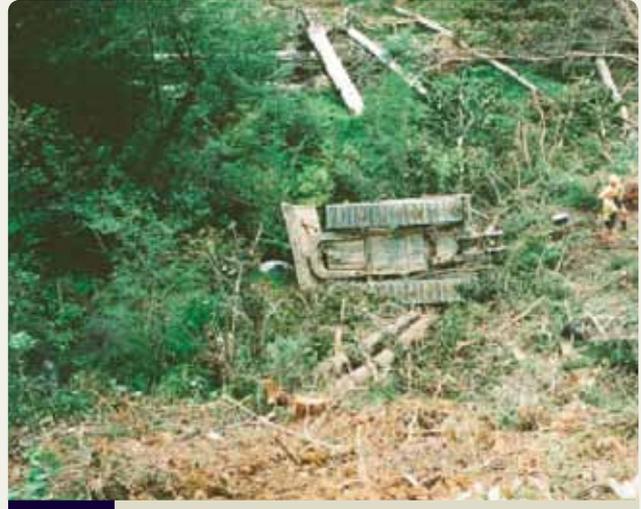
1

He was operating a Caterpillar bulldozer (Model 527) to extract logs. He was about to pull a third drag of two logs up a 34 degree slope to the skid site, but before he had started to winch the logs, the machine ran backwards over the edge of the track and down the hill, coming to rest 40 metres below. The worker was found unconscious and unrestrained in the cab.

View of the toppled bulldozer where it came to rest.

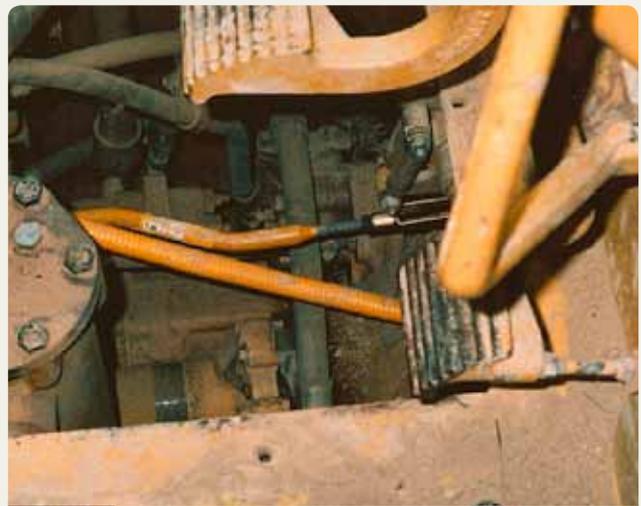
2

- An analysis by a metallurgy consultant revealed that the brake linkage may have been bent and straightened some time prior to the accident, and subsequently broke. The consultant expressed the view that this bend would have not been sufficient to cause the failure. Instead, he felt the damage to the brake linkage may have been caused by incorrect routing of a hydraulic hose, generating additional fluctuating stress along the threaded portion, and leading to fatigue cracking.

View of the newly-fitted brake rod.

It is important to be aware that damage could occur to safety-critical parts such as brake linkages during maintenance and repair work. Such parts should be checked before the machine is put back in service.
