Falling Borehole Pump Causes Uncontrolled Movement of Cables and Cable Reels

Mine Type: All Mine Types

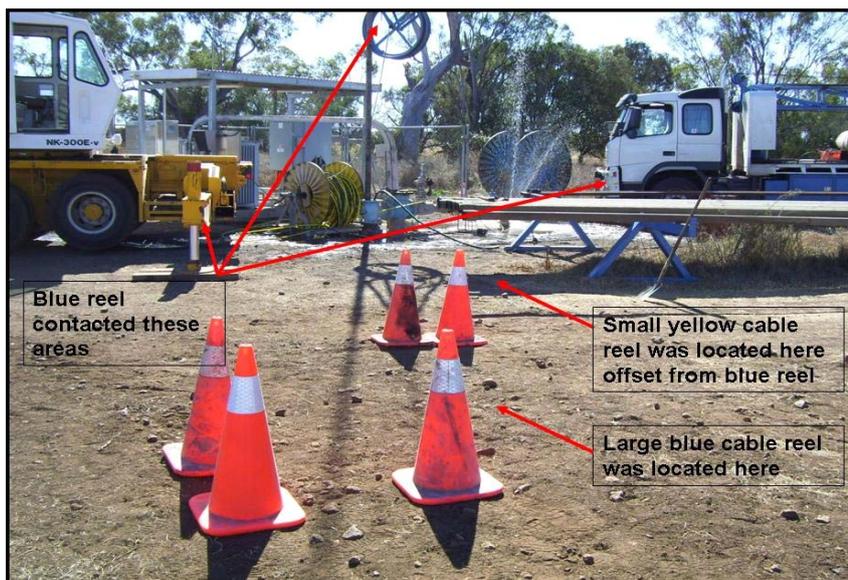
When 130 metres of rod had been removed, the cables were suddenly drawn back down the borehole, with both cable drums pulled rapidly towards the collar. The larger drum ricocheted off the crane outrigger and struck the sheave above where the operators had been standing. It then struck a nearby truck before coming to rest about 15 metres from its original location. The employees took evasive action to avoid being hit by the cable drums.

Cause: As each rod was rotated at the collar to untwist the cables, the rod string was uncoupling at a corroded joint in the borehole.

In this incident, the cable drum frames were not secured to the ground, nor was there any mechanism to control the rotation of the cable drums.

The threads of the drill rods where the rod string parted were heavily corroded. There was no strategy for maintaining the integrity of the rod string in a potentially corrosive environment.

- Effectively anchor or restrain cable drum assemblies to withstand the maximum anticipated load.
- Use powered cable drums to control drum rotation and braking.

- Delineate no-go zones in the vicinity of cable paths between cable drums and the borehole collar.
- Consider including a copy of this Significant Incident Report as an attachment to procedures developed for cable lowering and raising activities to maintain an ongoing awareness of this incident.
