Safety alert 224  
Published 19 June 2009

## Flushing Canister Bursts

**Mine Type:** All mine types

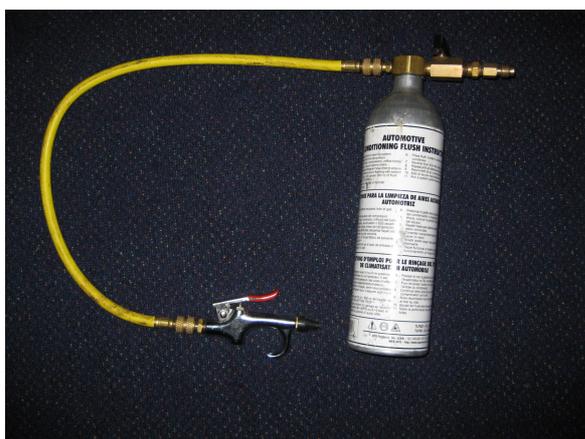
Before

The flushing canister is filled with a cleaning solvent. As pressurised gas is passed through the canister head, solvent is picked up and passed through a low pressure hose via a trigger operated delivery handpiece. The canister and gun unit has an instruction affixed which states that the unit should be connected to shop air at a pressure of six to 10 Bar (90 to 150 psi).

- **Flushing canisters should be fitted with an engineered pressure relief system, either from new, or prior to use on site.**
- Where possible, avoid using high pressure gas sources for similar tasks; consider using air compressors fitted with delivery air filtration. Where this is not possible, ensure that delivery side regulator pressure can not exceed the safe working pressures of the components it supplies.
- The mine should establish the competencies required for air conditioning work and ensure this work is undertaken by competent people.
- When equipment to be pressurised comes to site, it must be scrutinised to ensure it is fit for purpose.

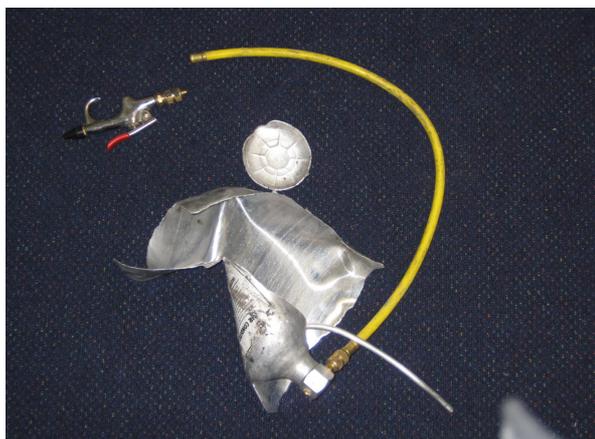
After

**Incident 1.** A fitter suffered deep lacerations to his upper legs, from groin to knee, when an aluminium flushing canister he was using burst. It is believed the catastrophic failure was due to over pressurising the canister, which was not fitted with a pressure relief valve.

In this instance the canister and gun unit was supplied pressurised gas from a nitrogen gas cylinder which has a nominal charge pressure of 16,300 KPa (2,300 psi). The cylinder was fitted with a pressure regulator, normally used to recharge accumulator components that may require pressures up to 16,000 KPa. At this time it is not known what pressure was being delivered through the regulator, as investigations are continuing to determine the pressure.

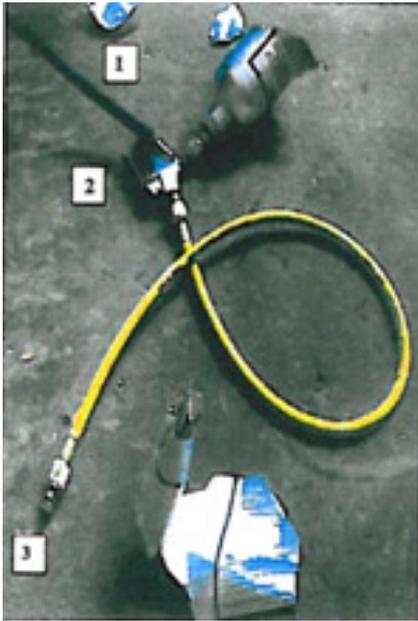
**Incident 2.** A contractor with 25 years experience on air conditioning systems was flushing out an air conditioning system on an integrated tool carrier vehicle. He was using an ERG Universal Flushing Agent. He had a hose connected from the nitrogen cylinder to his own low/high pressure gauge manifold. From the low pressure port a hose was connected to the flushing canister (1). There is a tap to control the output from the manifold. From the flushing canister, there was a hose to deliver the flushing agent into the air conditioning system. The rate of delivery was controlled by a trigger (2) at the end of the output hose.

By opening the tap on the low pressure side of the manifold with one hand, and holding the trigger open on the output hose from the flushing canister with the other hand, he flushed out the air conditioning system. As this process was almost complete, some flushing agent got into his eyes and he let go of the trigger holding the line open. This allowed pressure to build up in the flushing canister causing it to burst. The attachment of this hose (3) was ripped out of the canister.

Investigation showed that the regulator on the nitrogen cylinder was set at 1100psi and the flushing canister was rated at 150 psi. The mechanic received cuts to his neck and jaw requiring 20 stitches. He was wearing safety glasses.
