Safety alert 210
Published 30 October 2008

Dozer Falls from Bench

Mine Type: All Surface Mines

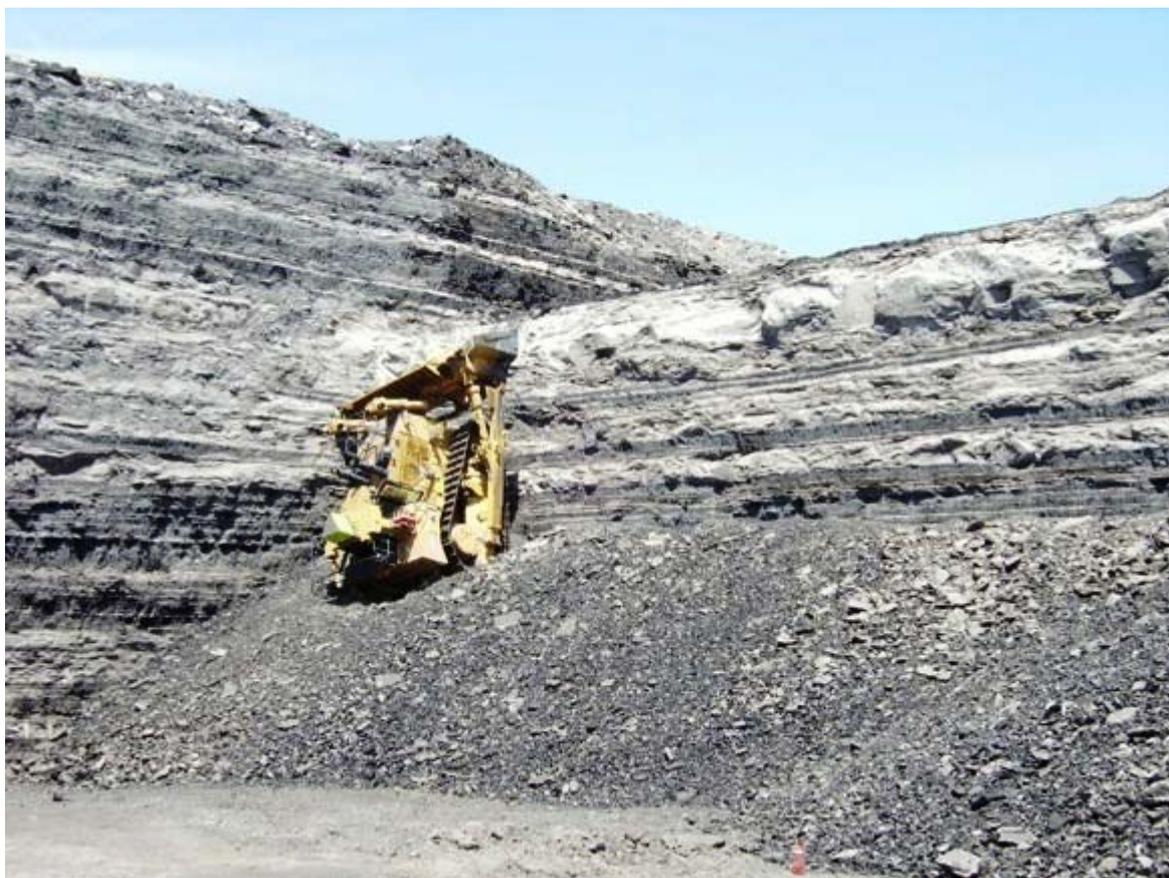
Incident: During dayshift at a surface coal mine, a dozer operator was cleaning along a bench to remove a ramp. The operator was reversing into position to push material forward when the dozer dropped over the edge of the bench, falling about 12 metres onto a pile of loose material. The dozer remained in a vertical position. The operator was uninjured and was evacuated by emergency services personnel.

Equipment: Caterpillar D11T Dozer

Hazard: Fall of earth moving equipment from a bench

Cause: The operator overestimated the clearance he had between the bench edge and the material he was going to push.

Review the adequacy of control measures in place to prevent earthmoving equipment from falling over bench edges. Refer to the Alert relating to recent dozer accidents on the following United States Mining Safety and Health Administration website for further information on risk control measures: <http://www.msha.gov/Alerts/SafetyFlyers/DozerAlert102008.pdf>

Consider applying current GPS technology to assist earthmoving equipment operators working on benches to accurately locate their position relative to the bench edge, and to identify no-go zones.

Also consider the use of remotely controlled earthmoving equipment when operating in the vicinity of a bench edge where it is not practicable to construct a safety berm.

Communicate the hazards and risk control measures, identified in risk assessments for the introduction of new earth moving equipment, to the affected mine workers. Do this before the equipment is put into operation.

Monitor the initial operation of new earth moving equipment to verify the effectiveness of control measures. Continue to monitor, as appropriate, for the risk of the task being undertaken with the equipment.
