# SAFETY ALERT

## Worker crushed by sliding backhoe

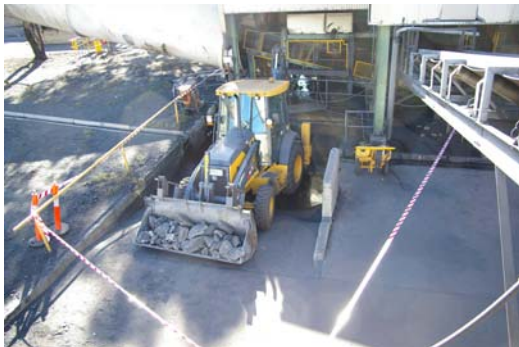
Workers were attempting to lift a steel floor plate into position with the aid of a backhoe loader. The backhoe was positioned on a 1-in-4.7 slope entry to a sump containing water and coal fines.

When the backhoe driver deployed the stabiliser jacks, the machine began to slide down the slope towards the other workers. The boom on the backhoe forced the handrail onto a worker, entrapping him and causing injuries. Evasive action by the backhoe operator averted a more serious outcome.

Photos: The backhoe loader involved in the incident (above left), and the backhoe boom (above right).

Where earth moving equipment (eg backhoes, front end loaders, excavators, telescopic handlers, tool carriers and other similar units) have been selected to act as a crane for the purpose of raising, lowering or transporting loads, the requirements of AS 1418.8-2002 *Cranes, hoists and winches Part 8: Special purpose appliances* should be reviewed and considered as part of the risk assessment to select plant to undertake the tasks of lifting and/or transporting loads.

Work that is intended to be carried out using this type of equipment should be subject to risk assessment and the development of written safe work procedures.

Risk assessment and safe work procedures should result in the most appropriate machine being selected for the task, and should identify all safeguards to ensure that no person is placed in a position around the machinery where they may be injured.

- suitability of the equipment to operate on a slope
- ground conditions where the machine is to operate
- testing of machine stability prior to lifting
- positioning of observers and bystanders
- use of tag lines for controlling the load
- the evaluation of the stabiliser foot pad material to ensure the foot pads are the correct type for the ground conditions being encountered.
