SLOPE STABILITY RISK MANAGEMENT AT ANGLO PLATINUM'S SANDSLOOT OPEN PIT

Alan Bye, Geotechnical Engineer, Anglo Platinum
**Megan Little, Rock Engineer, PPRust, Anglo
Platinum**
**Desmond Mossop, Manager Rock Engineering,
PPRust, Anglo Platinum**

36th ANNUAL CONFERENCE & EXHIBITION
Birchwood Conference Centre,
Gauteng
3-5 MARCH 2005

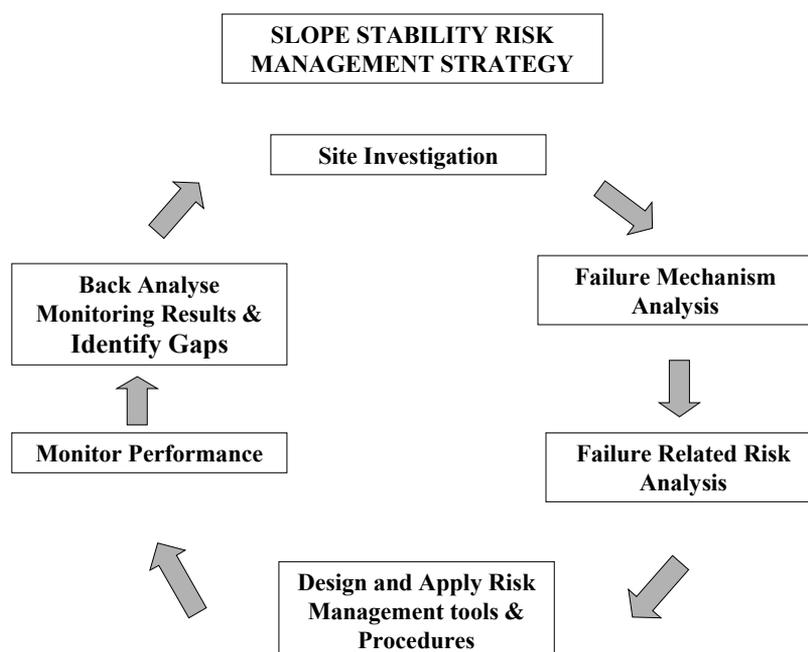
Figure 1. Risk management strategy applied at PPRust.

Geology and the detailed understanding of its properties are fundamental to the optimal design and successful operation of any mine. As the knowledge of the geotechnical conditions improves so the risk of unforeseen conditions reduces and therefore safety and productivity can be increased. The paper documents the procedures and developments undertaken to compile a slope stability risk management process at PPRust (Potgietersrust Platinums Ltd.) as illustrated in Figure 1.

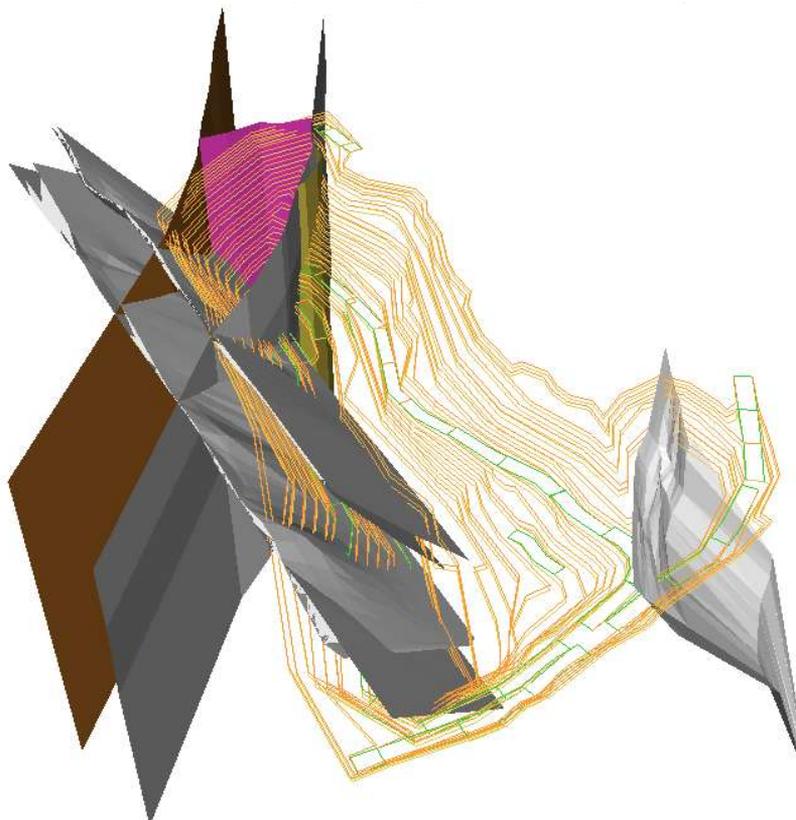
Figure 3. 3D view of the Sandstoot design pit displaying the major structural features.

The Satellite Pit Fault in the south-eastern corner of the pit has downthrown the reef by 50 m while the Sandsloot River on the northern and western pit limits follow another major fault locally called the Sandsloot Fault (Figure 3). According to Friese (2003), these two faults combine to form a major duplex that encloses Sandsloot open pit. Three major joint sets have been identified at Sandsloot, namely JS1 (60/090), JS2 (70/180) and JS3 (70/120). The footwall is stable while the hanging wall contains brittle planar failures, as a result of large-scale fault zones that cross-cut the entire pit (Figure 4). They are ubiquitous and run sub-parallel to the western wall and have an average dip of 60 degrees to the east. Failures, varying in size from 300 t to 30 000 t, have occurred on these fault zones posing the biggest slope stability concern in Sandsloot.

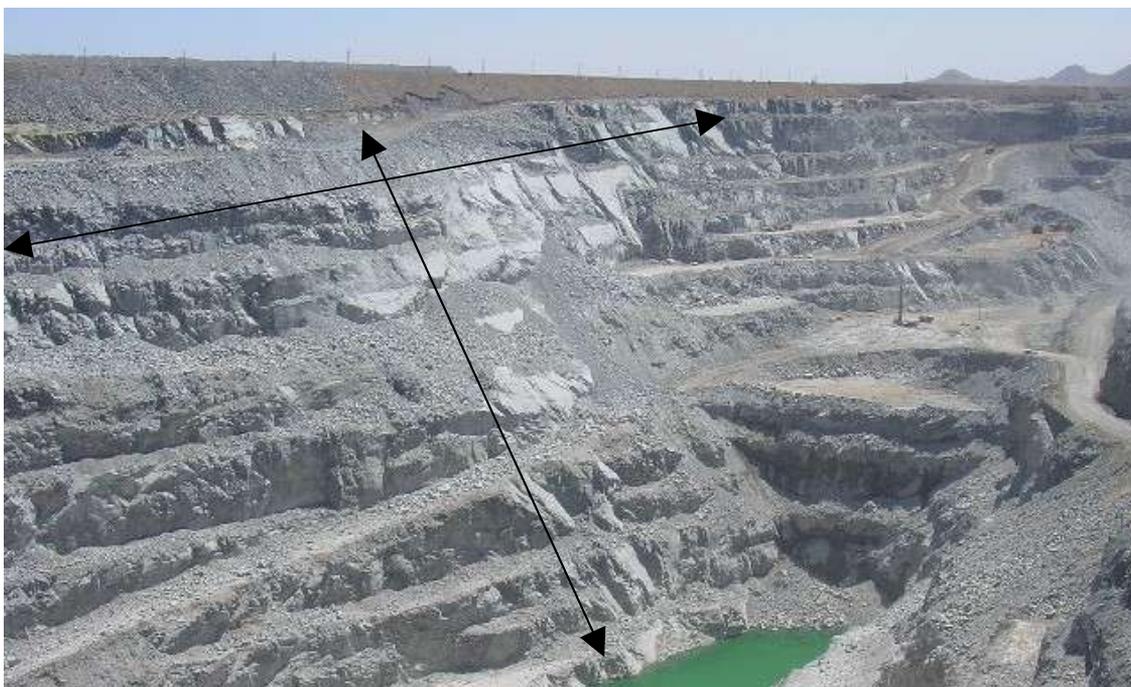
Figure 4. Photograph of fault zones cross-cutting the west wall cutback of the Sandsloot pit.

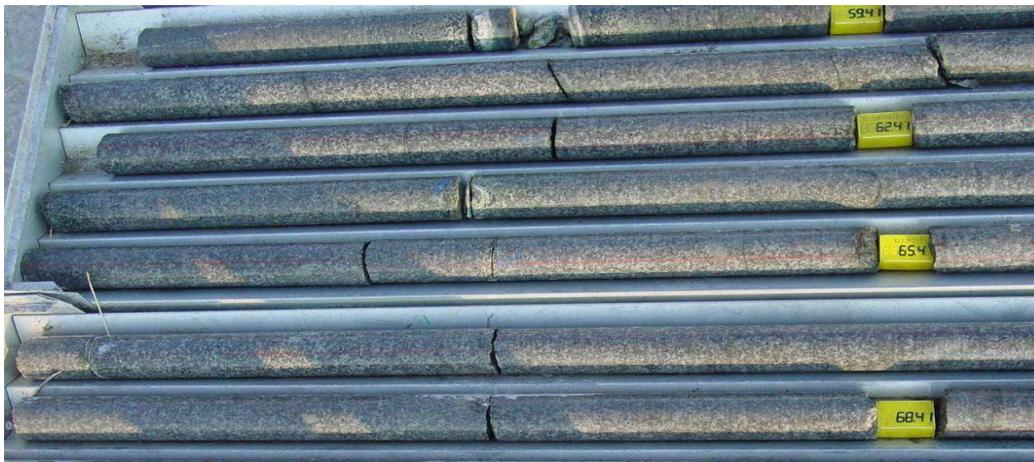
Figure 5. Photograph of the difficult to identify 'fault zone' occurring in SS02, which was intersected during mining as illustrated in Figure 6.

Orientated diamond drill holes were drilled into the western high wall and the core was logged geotechnically. Particular notice was taken of calcite veins and infilling on joints as the major failures consistently display vein filling on their surfaces. The aim of the drilling programme was to locate the exact positions of the fault zones in the western high wall so that the slope design could be customised. The structural data collected from the boreholes was listed in Excel and plotted on stereonet in DIPS and analysed. This was the best method of identifying the fault zones as the core is very competent and gave very high RQD's of between 95 and 100 per cent (Figure 5). The core confirmed the 0.5 m joint spacing and 10 m width of the critical fault zones seen in the field. Figure 7 displays a geotechnical section of the western high wall with the exploration boreholes and fault intersections.

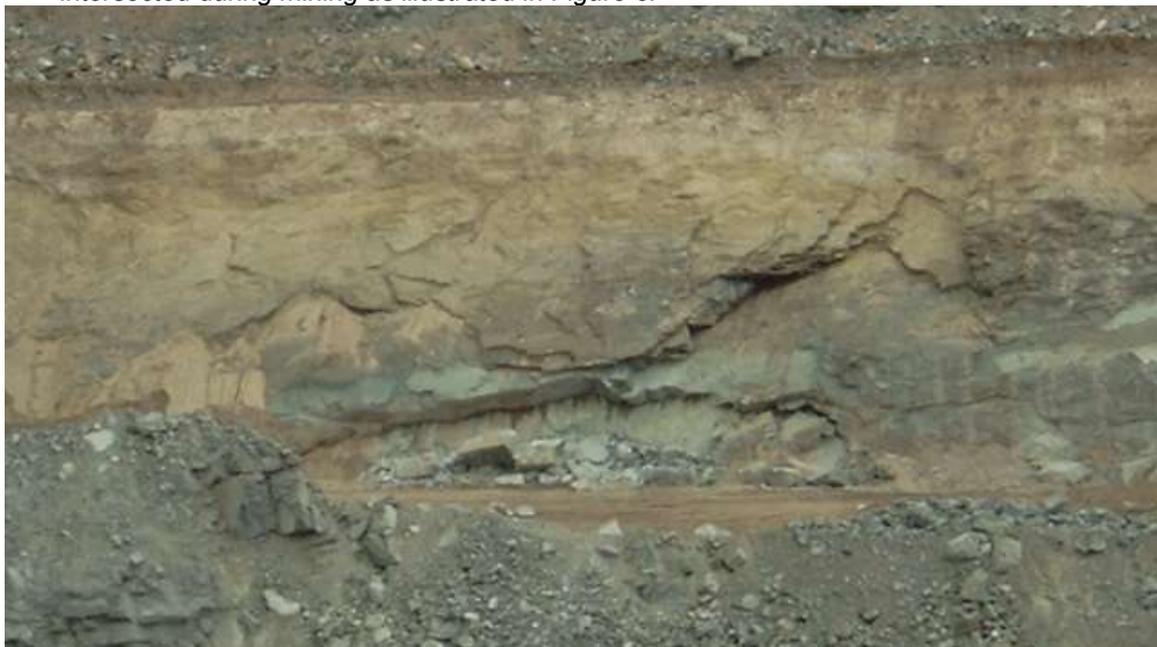
Figure 6. Small scale failure caused by the fault zone logged in SS02 above. The closed felsite veins were disturbed by blasting and the failure was initiated by heavy rainfall and loading operations.

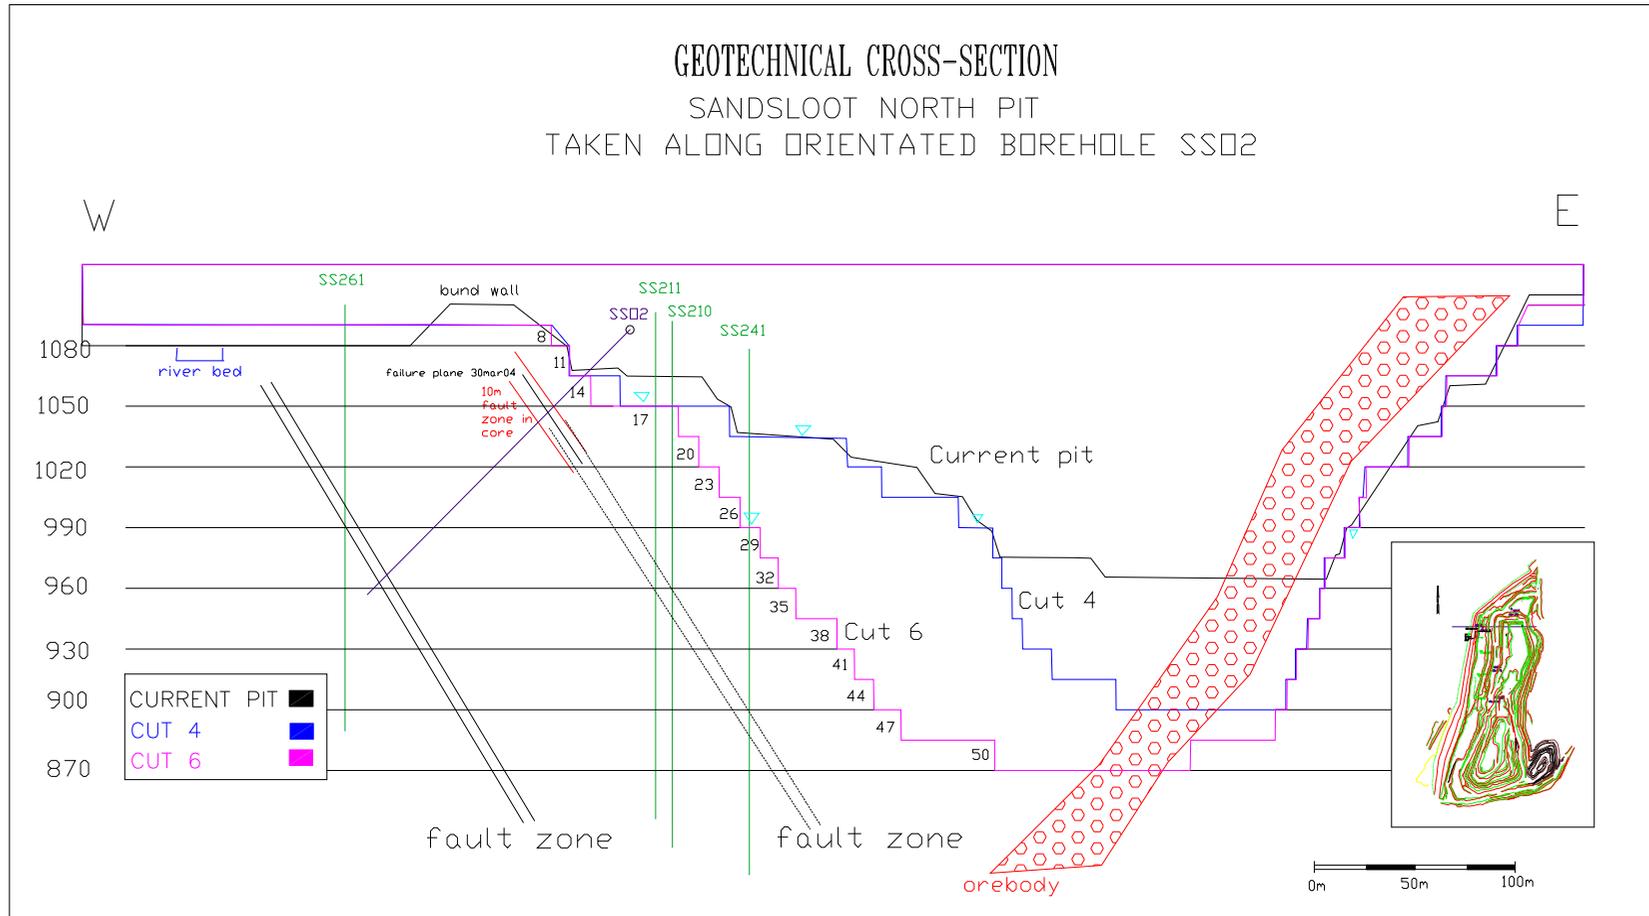
Figure 7. Cross-section through Sandsloot North Pit, taken along orientated borehole SSO2 and including exploration diamond drill holes, all of which were used to delineate the expected fault zones.

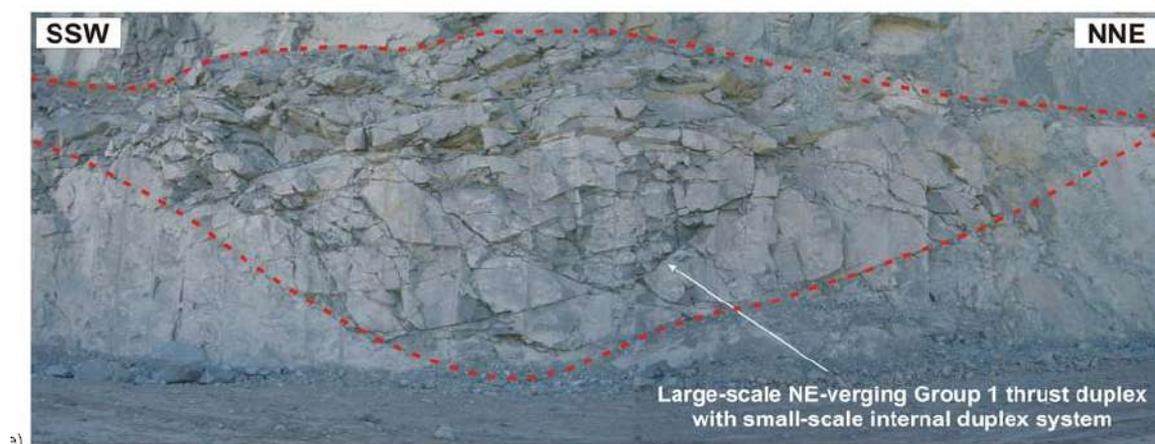
Figure 8. Photograph of the western high wall illustrating the duplex structures (Friese, 2003).

Two major fault sets (historically called Joint Set 1 and Joint Set 3) were identified and found to be continuous within the major duplex, bounded by the Sandsloot Fault in the north and the Satellite Pit Fault in the south. The fault sets correlate with the regional structure and the large scale duplex is repeated on a small scale throughout the pit (Figure 8). This is most prevalent on the west wall where imbricate fans occur within the duplexes to form fault zones which sit above the basal normal faults. The fans contain a closely-spaced set of joints which become progressively steeper with increasing distance from the basal fault, resulting in a change in dip of up to forty degrees within a fan. These fault zones are 10 – 80 m wide and 100 - 130 m apart while the duplexes are 70 m in length along dip. This duplex fan phenomenon in conjunction with the large-scale undulations on the joints, cause uncertainty in predicting the location and the probability of failures.

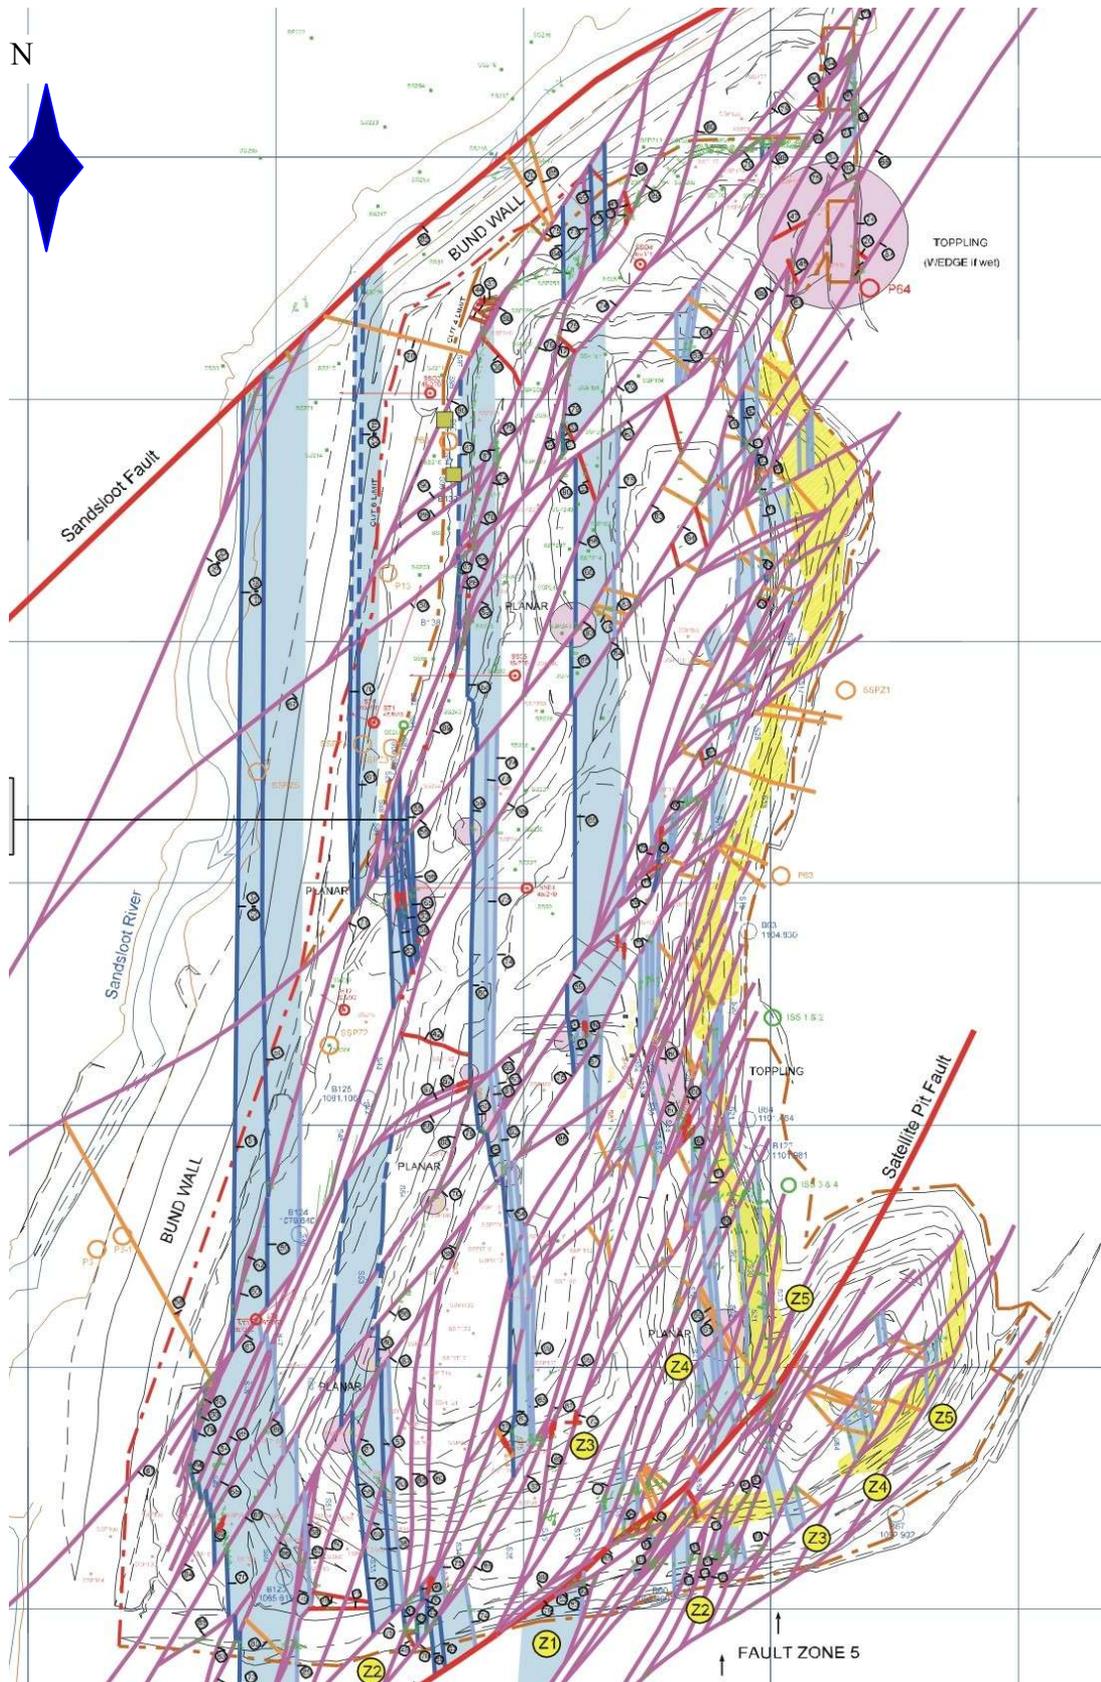
Figure 9. Structural map of Sandsloot open pit indicating the major structural features intersecting the open pit (Friese 2003).

Detailed line mapping was performed throughout Sandsloot pit on accessible faces and combined with the existing geotechnical mapping database. Interpretation of geophysical and remote-sensing data sets was undertaken on a regional scale and diamond drill exploration core was assessed (Friese, 2003). The aim of this work was to delineate the fault zones and the major structures at Sandsloot and create a Structural Interpretation Map of the pit (Figure 9).

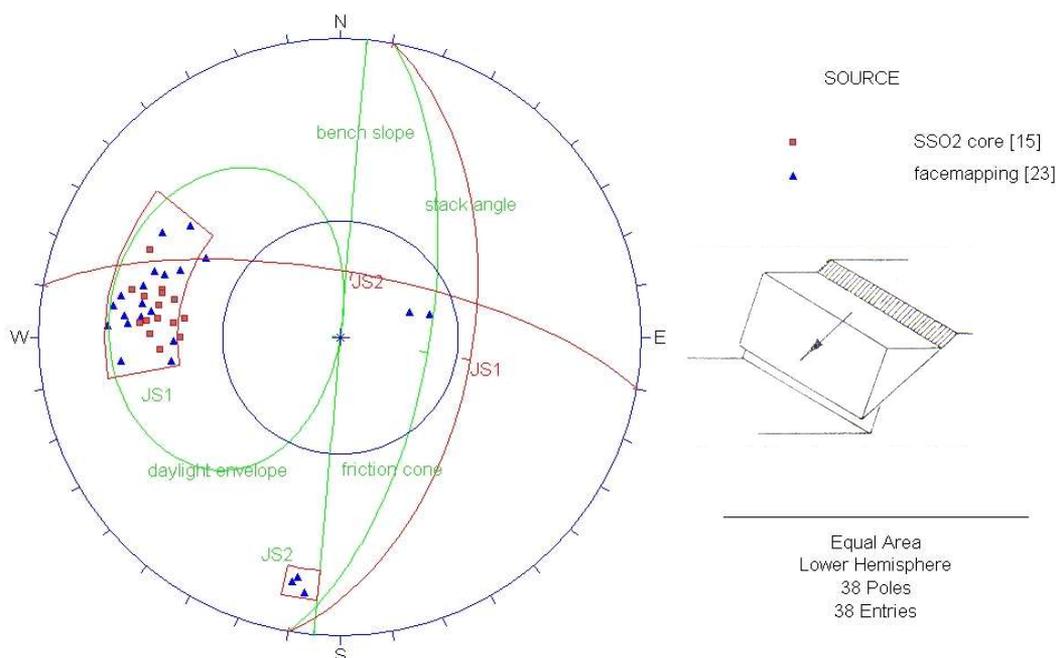
Figure 10. DIPS stereonet of face mapping and core logging measurements from a recent planar failure on the west wall

In basic terms the failure mechanism on the western high wall can be defined as planar failure, whereby a joint bounded block of rock slides down-slope along a planar surface as shown in Figure 10. To satisfy the requirements of a kinematic planar failure the joints must day light in the slope face, they must dip at a steeper angle than the base friction angle, the sliding surface should strike sub-parallel to the slope face and a separate perpendicular joint set must provide release surfaces. All these requirements are satisfied by the structures evident on the western high wall.

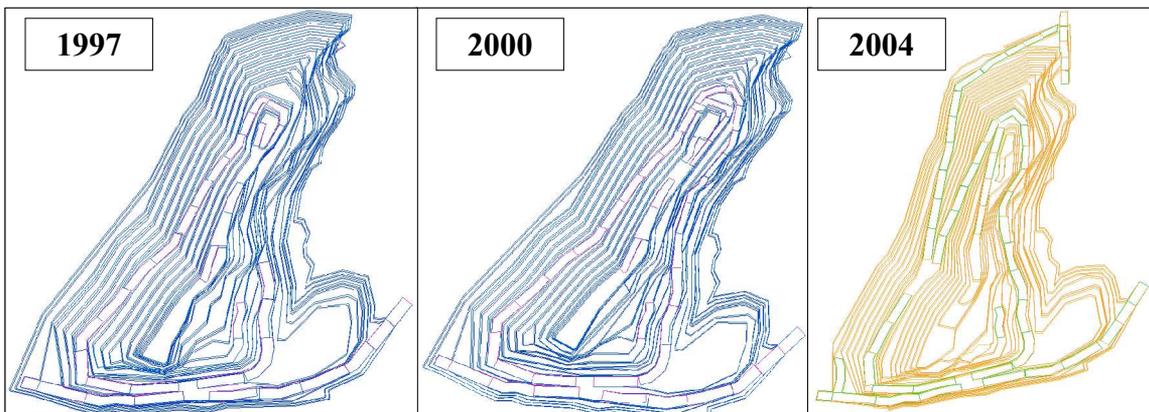
Figure 11. Change in the Sandsloot pit design from 1997 to 2004.

Figure 11 illustrates the changes in the final Sandsloot pit design. Prior to the intersection of the major fault structures on the western high wall a single hanging wall ramp was sufficient to ensure reliable pit access. Subsequently a footwall ramp was included to reduce the likelihood of losing access to the pit through a ramp failure. The approach of multiple access ramps was further developed with three access included in the 2004 pit design. Not only does this give operational flexibility for optimising short hauls it also provides security for the long term access to the base of the open pit. It is important to note that the access ramps can be productively used as slope catchment berms so that the overall slope angle is not compromised.

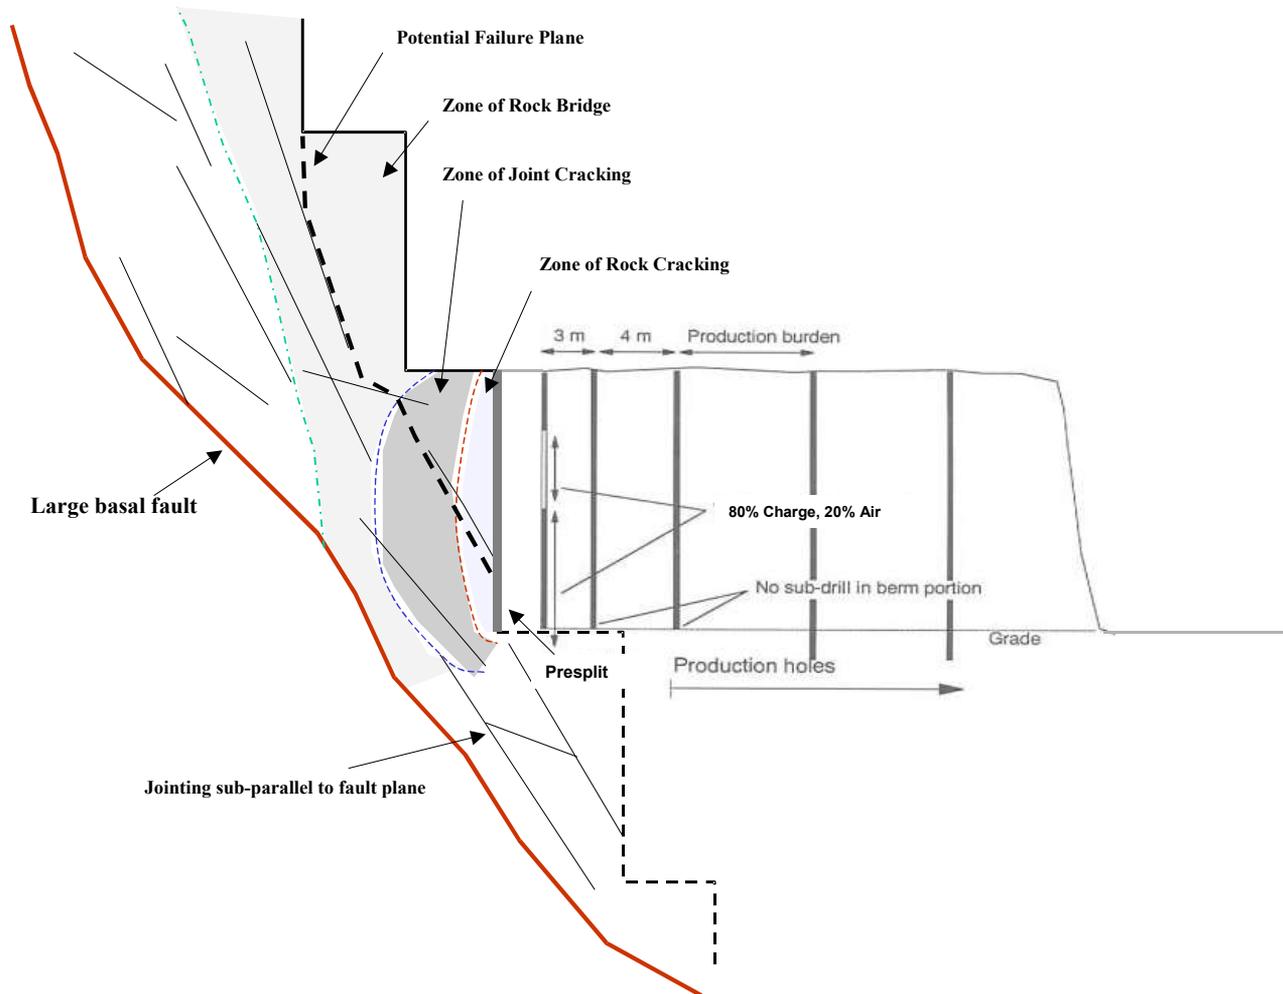
Figure 12 Illustrates the impact of blasting on the competence of a highwall.

The failure mechanism evident on the western highwall is however more complex, as the release surfaces provided by JS2 are discontinuous. In order for failure to occur the releasing joints must shear through the 'rock bridge' or competent norite situated between the discontinuous joints. The scale of the planar failures are therefore controlled by the extent of the blast damage and the depth of the rock bridge zone as illustrated in Figure 12.

Figure 12 illustrates a design section through the Sandsloot western high wall. The typical wall control blast layout is presented with presplit, buffer and trim blast holes of 165mm diameter. As introduced in the rock strength testing section, the impact of blasting energy on the stability of the wall is controlled by the joint and rock strength parameters.

In order to understand what was initiating the slope failures, an analysis of the blast pressures generated by the wall control blasts was undertaken. Three zones are identified in the design section and these should be read in conjunction with the chart presented in Figure 13.

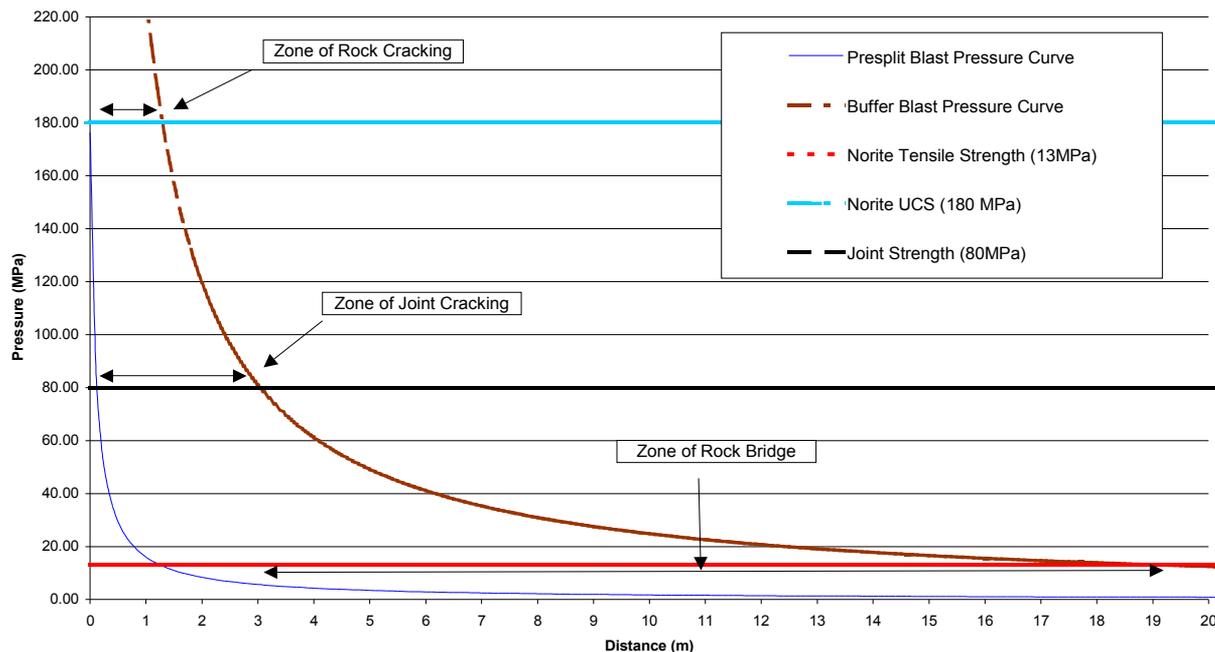
WALL CONTROL BLAST
Pressure vs Distance

Figure 13 Assessment of blast damage zones from a wall control blast. The chart illustrates the drop of blast pressure from a blast hole with distance and to what extent fracturing of different rock materials occurs.

- Zone of rock cracking
 - ~ The blast hole pressure generated by the blast is higher than the UCS of the host rock and cracks are created around the blast hole. This is a confined zone (+/- 2m) immediately adjacent to the blast hole.

- Zone of joint cracking
 - ~ The strength of the joint filling is overcome by the blast hole pressure, resulting in the opening up of the sealed joints (+/- 3m). Depending on the joint strength and the tensile or compressive failure mechanism this can extend to significant distances behind the face.

- Zone of rock bridge
 - ~ Zone of discontinuous rock mass breaks where the tensile strength of the rock and the joints are overcome. This creates a partially fractured rock mass with variable lengths of 'rock bridge' on and between joints. With continual dynamic loading from blasting and mining activities the width of the rock bridge can deteriorate to form a step path failure plane. As seen in Figure 13, this can extend to 20m behind the design limit.

Field observations confirm the graphical analysis results with the failures at Sandsloot occurring in discrete zones where the joint strength is overcome by blasting and the failure is initiated by groundwater pressures or removal of toe support. The failures are typically less than 20,000t and extend to a depth of 10m-20m behind the high wall. It must be noted that if sensitive wall control practices were not being applied, the extent of the blast damage would be greater and this would result in larger and more frequent failures. In turn this would result in unmanageable risk levels.

The impact of the blast pressures on the joint filling was analysed to determine the depths of damage and therefore expected failure volumes. Blast hole pressure versus distance curves were analysed in order to assist with understanding the failure mechanism. Based on the potential blast damage zones and the intersection of the major west wall structures, areas of potential failure can be identified.

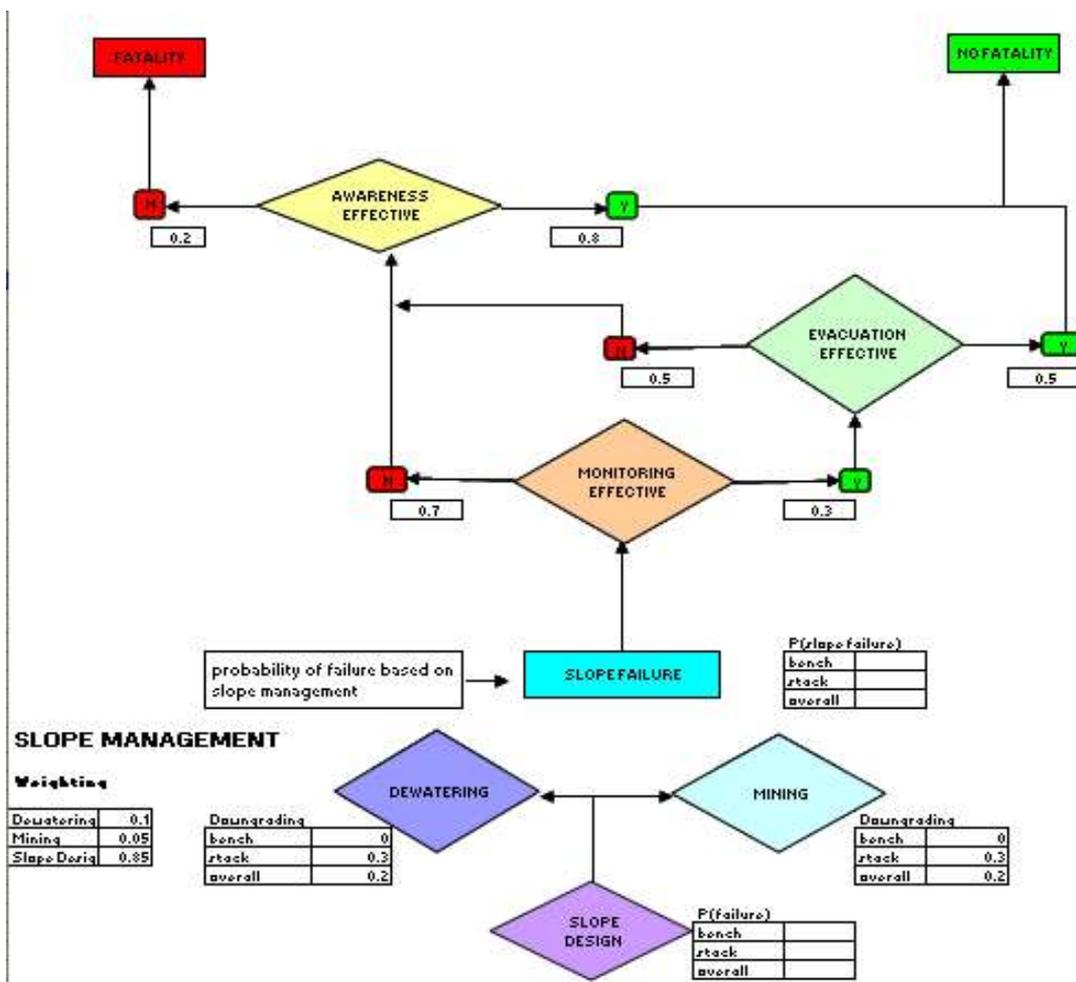
Figure 14. Fault tree designed for Sandsloot
 Probabilities of fatality at Sandsloot

At Sandsloot, a fault tree analysis was done in order to quantify the risks posed by the failures on the western high wall. The fault trees were designed to calculate the probability of a fatality, which was then compared to the international acceptable level of risk (Figure 14). Failure on a bench, stack and overall slope was used as the root cause/event and the design probabilities of failure assigned. The design probabilities, calculated from Slide (RocScience, 2003) and kinematic failure analysis, were adjusted to take into account operational conditions, such as wet slopes and the impact of blasting. Risk mitigation measures the effectiveness of monitoring, personnel awareness and evacuation in response to a failure was incorporated in the fault tree and personnel exposure to the failure incorporated to produce an overall probability of fatality.

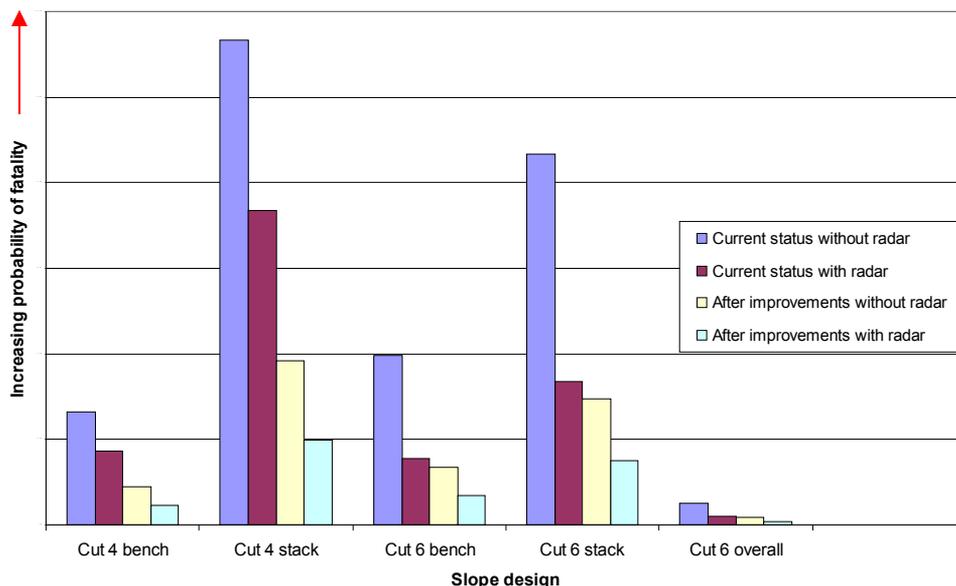
Figure 15. Risks obtained from the fault tree analysis

Various fault tree scenarios were run to determine the effect that improved monitoring techniques as well as improved awareness, evacuation, dewatering and wall control would have on mitigating risk to personnel at Sandsloot. In particular, the effect of the GroundProbe slope stability radar was studied. Bench, stack and overall slopes for the current Cut 4 as well as the final Cut 6 designs were analysed. Results from the analysis show that failure on a bench and especially stack scale are the highest risk in Sandsloot. The slope stability radar significantly reduced the safety risk thereby allowing operations to continue within internationally accepted safety standards (Figure 15). Other improvements such as training, slope design configuration, operations work procedures, awareness, evacuation drills and slope dewatering also have a large effect on reducing risk and are an essential part of the risk management programme.

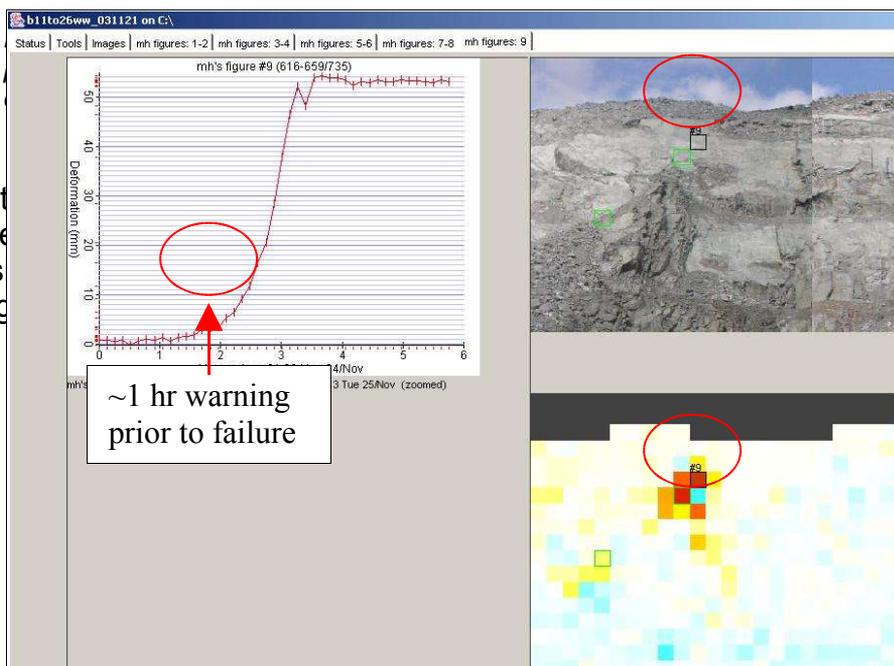
Figure 18. SSR screen dump with deformation-over-time plot, photograph and deformation image of the 20 000t brittle failure in Sandsloot open pit on 20 March 2004.

The first international SSR unit arrived on site at PPL in November 2003 and was trialled for the 2 months. During the trial at PPL, the SSR recorded a minor slope failure and triggered a red alarm, which enabled early warning to be given to pit personnel. As no work was underway in the vicinity, production was not affected but the failure proved that the radar was the appropriate monitoring tool for Sandsloot. The <300 t failure showed up on the SSR plots as an exponential curve of 54 mm movement over 120 minutes (Figure 16). This indicates that rapid response to slope failures at PPL is required in order to keep personnel safe and to minimise damage to equipment.

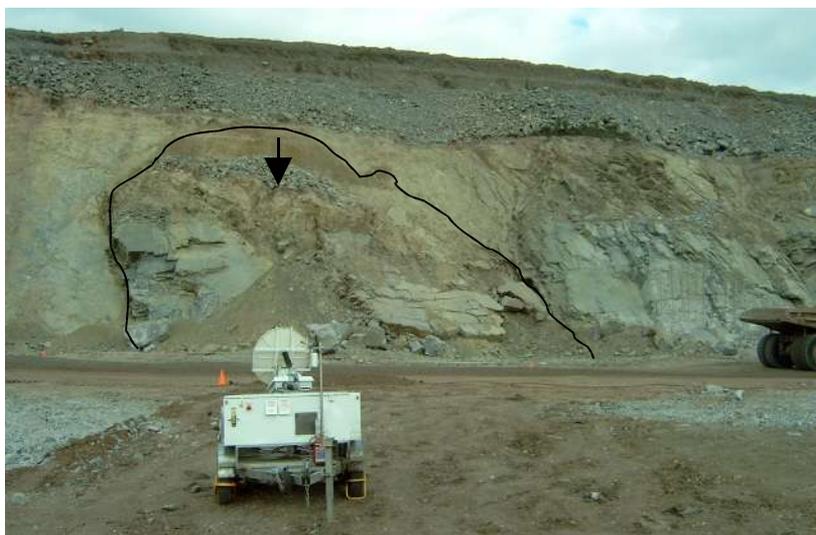
Figure 17. Photograph taken on 31 March 2004 of the radar and the failed block that was monitored.
