## Mines Safety Significant Incident Report No. 170

### Gold room explosion – integrated pressure strip electrowinning (IPSE) circuit failure

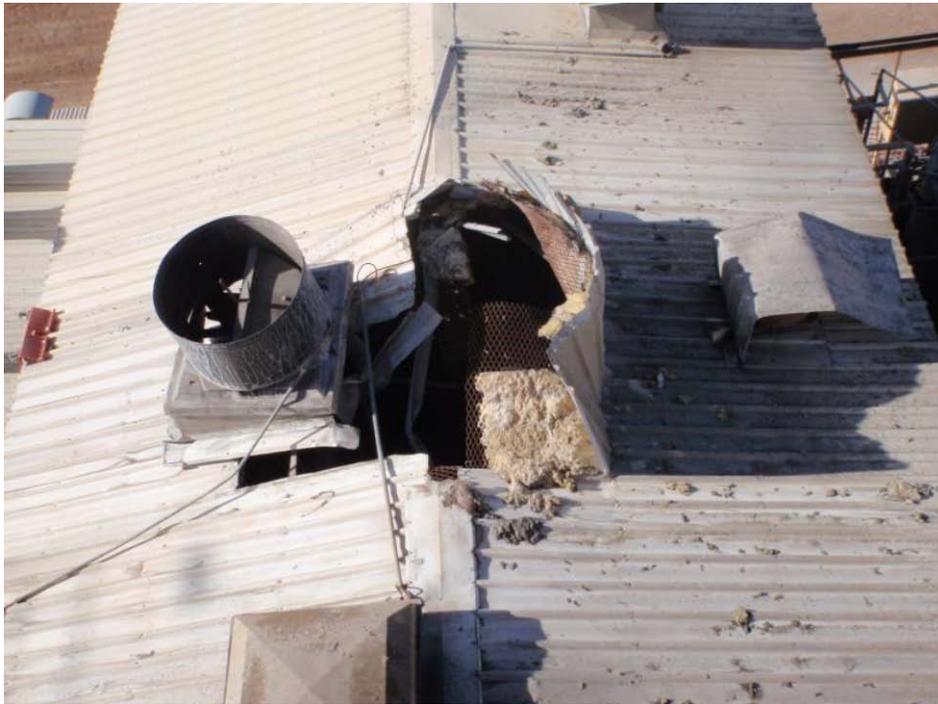
A pressure vessel containing one of the electrowinning cells of an integrated pressure strip electrowinning (IPSE) circuit catastrophically failed during a gold stripping process. The lid of one of the pressure vessels was blown off after the 24 holding bolts were broken or their threads stripped. The heavy lid, weighing about 500 kg, punched a hole in the gold room roof before falling to the floor.

Figure 1 Damage caused when the 500 kg IPSE lid punched through the gold room roof

An independent investigation by a gold processing specialist advised that there had been a sudden and explosive release of energy due to hydrogen and oxygen build up in the electrowinning cell. These are normal gaseous by-products of electrowinning but the mixture is explosive if the gas space above the electrowinning cell is not continuously purged by the passage of compressed air. The most likely cause of gas build up inside the vessel was the blockage of the electrowinning cell purge air vent valve, which would normally allow gases to be continuously bled from the system.

The root cause analysis concluded that an incorrect valve had been installed for the pressure relief system. The purge air vent valve is a 25 mm ball valve that has no indication, alarm or system interlock to warn of purge flow restriction. The installed valve was the wrong design and did not comply with

To avoid a recurrence of this type of incident, mine site corrective actions include:

- undertaking an engineering review to identify alternative electrowinning systems that eliminate the need for a pressurised and purged system; and
- reviewing the design and process and instrumentation drawing (P & ID) of the elution circuit to determine its current design compliance.
