Environmental Excellence Award 2009

**Puketutu Island
Quarry & Cleanfill**

Summary

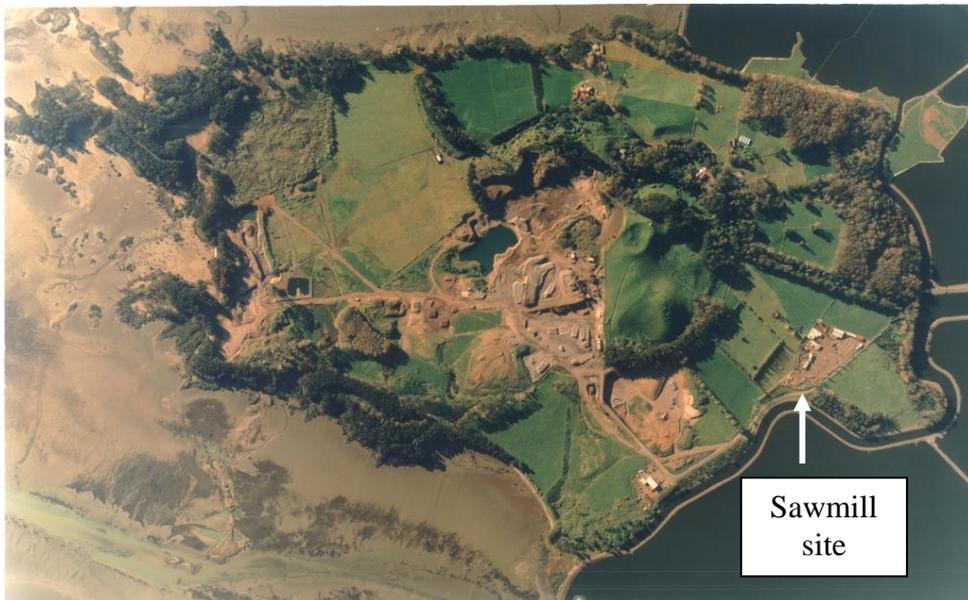
Another industry that was present on Puketutu Island was a sawmill which also treated timber. The location of the sawmill, which remained in operation until 2005, is shown in Figure 3 below.

Figure 3: Aerial photo of Puketutu Island showing sawmill location.

A sawmill complete with CCA (Copper, Chromium, Arsenic) timber treatment plant operated in an area of Puketutu Island for approximately 30 years. After treatment, timber was placed in the sawmill yard to drip dry. There is also anecdotal evidence that excess treatment chemicals were disposed of within the site. These operations contaminated groundwater within the site. As part of WA's lease, WA chose to remediate the sawmill site to allow for efficient extraction of the basalt resource.

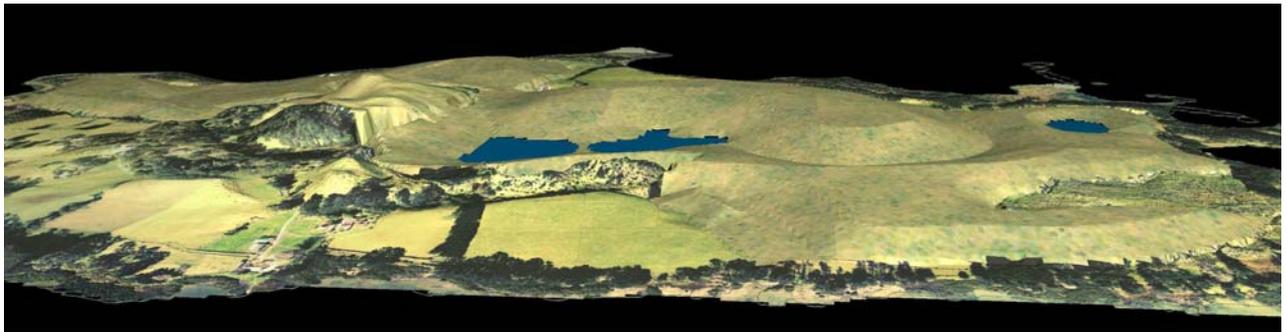
Cleanfilling on Puketutu Island began in the late 1980's as a means of rehabilitating the quarry to a desired land form rather than leaving an exposed pit. Figure 4 below shows the planned final landform for Puketutu that WA proposed and is the subject of ongoing consultation. Incoming cleanfill is used to produce the desired contours with clean clays and soils used for capping.

Figure 4: Planned final landform for Puketutu Island

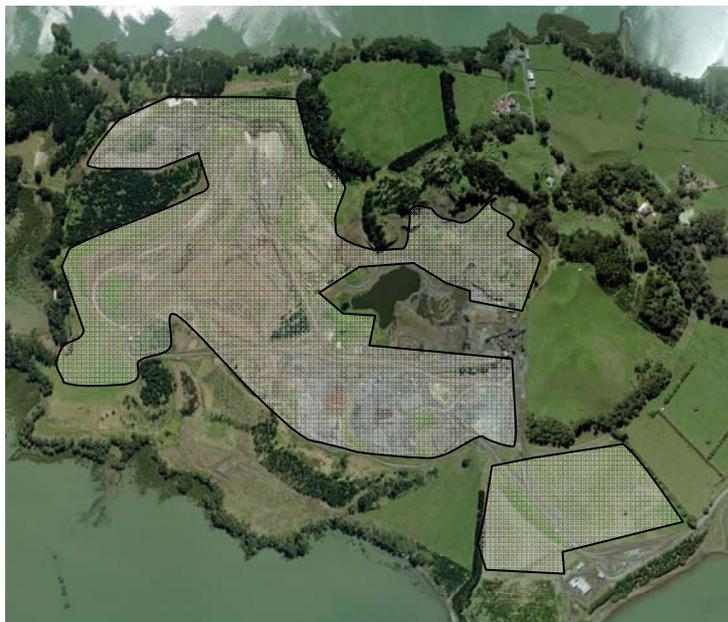
Cleanfilling also allowed for sustained extraction of basalt from Puketutu Island by allowing rock to be extracted below the water level with minimal effect on the island's aquifer system with the extracted rock volume replaced by incoming fill. This greatly extended the life of the basalt resource, enabling more rock to be made available close to Auckland City. Figure 5 below shows the areas of Puketutu Island that have been quarried and filled using the cleanfill process. Some of the area shown below is still being filled and another area (Area F) to the west of the figure has been quarried and will be filled over the next year.

Figure 5: Aerial photo of Puketutu showing clean filled areas post quarrying.

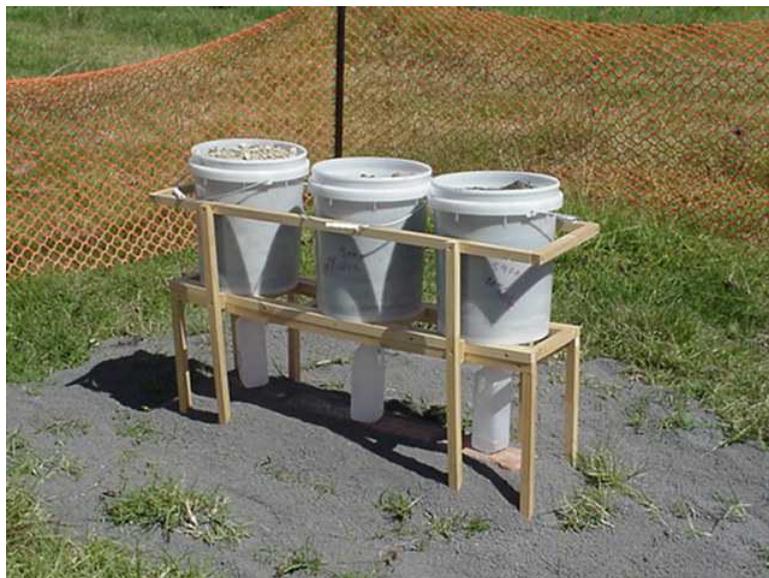
- Leaching tests were carried out to assess the risk of contamination and to ensure the islands aquifer areas were not contaminated from incoming fill. One of the leaching tests that was used is shown below in Figure 6.

Figure 6: Field Leaching Tests.

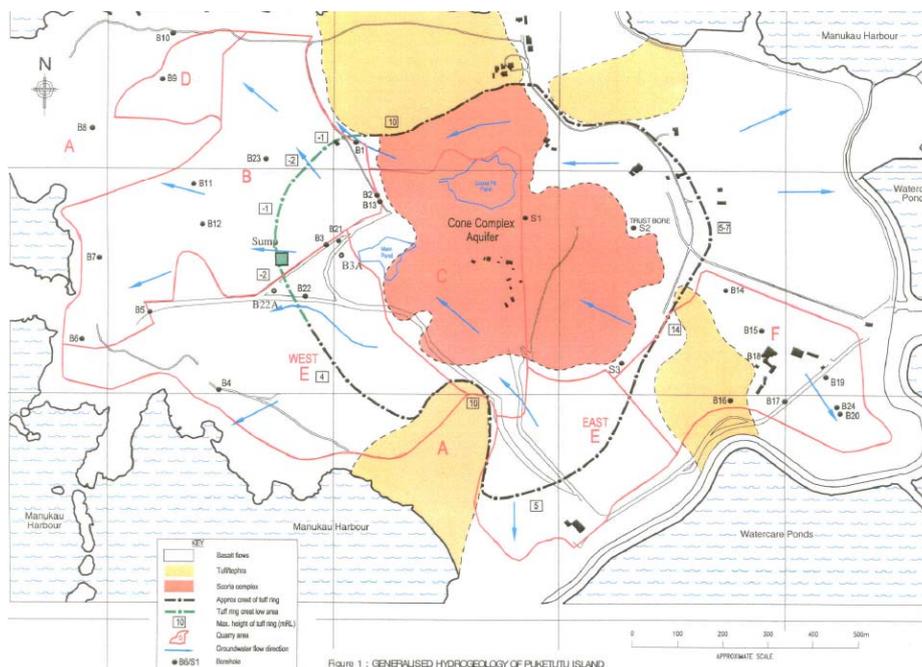
One of the aquifers located within Puketutu Island is the central aquifer, shown as the area inside the dashed line in Figure 7 below. This supplies the residents, employees and guests on Puketutu Island with drinking water and therefore the quality of the water in the aquifer must be maintained to a high standard. The following are steps that WA have taken ensure there is no detrimental affect on the central aquifer:

- Depending on contamination levels, Incoming fill is classified as either being suitable for tipping above the central aquifer or not. This creates a two tier acceptance system with different contamination thresholds for each:

- If the fill contains any asphalt, is untested or test results show contamination higher than the central aquifer limits then it is tipped in an area outside of the central aquifer.

- If the fill contains any DDT, semi volatile organic compounds, or heavy metal concentrations over those considered to be background for the Auckland volcanic region then these are also tipped in an area outside of the central aquifer.

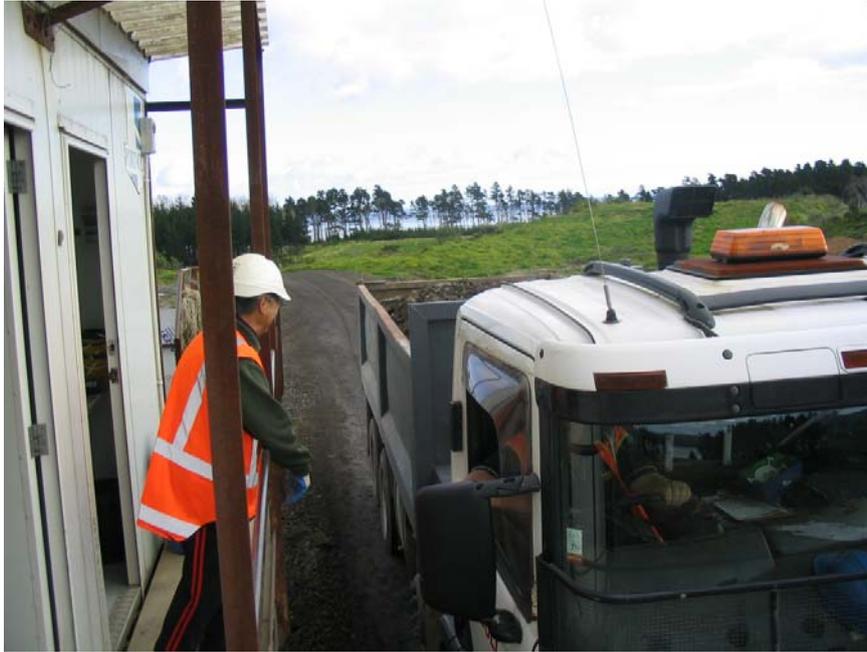
- WA staff carry out pre-acceptance checks of fill test results before accepting fill.
- WA staff carry out visits to customer sites before accepting fill.
- Presence of an Environmental Coordinator to oversee fill acceptance procedures.
- Every load is subjected to multiple inspection points once fill reaches site with inspection at the fill control point, as shown below in Figure 8, and again at the tip head.
- Use of XRF testing on and off site to give instant chemical results.
- Loads coming onto site are also subjected to random sampling and testing.

Figure 8: The fill inspector inspecting a truck load before it tips off.

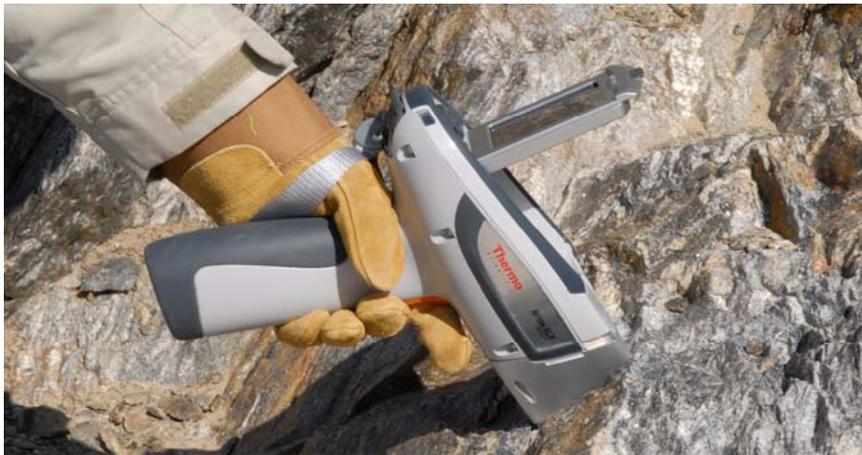
Figure 9: A hand held XRF.

XRF stands for X-Ray Fluorescence and provides instant and accurate analysis of soils by identifying the presence of heavy metals and their concentrations. Each element in the periodic table has a unique spectrum when exposed to X-Rays. When a sample is exposed to the X-Rays and the spectrum measured, concentrations of each element in the sample are provided by the XRF machine.

At times the XRF is used at the fill inspection point to test all or every other truck that is coming into site to make sure incoming fill is suitable. The XRF was also used extensively in the sawmill clean up as mentioned in the Sawmill Remediation section of this application.

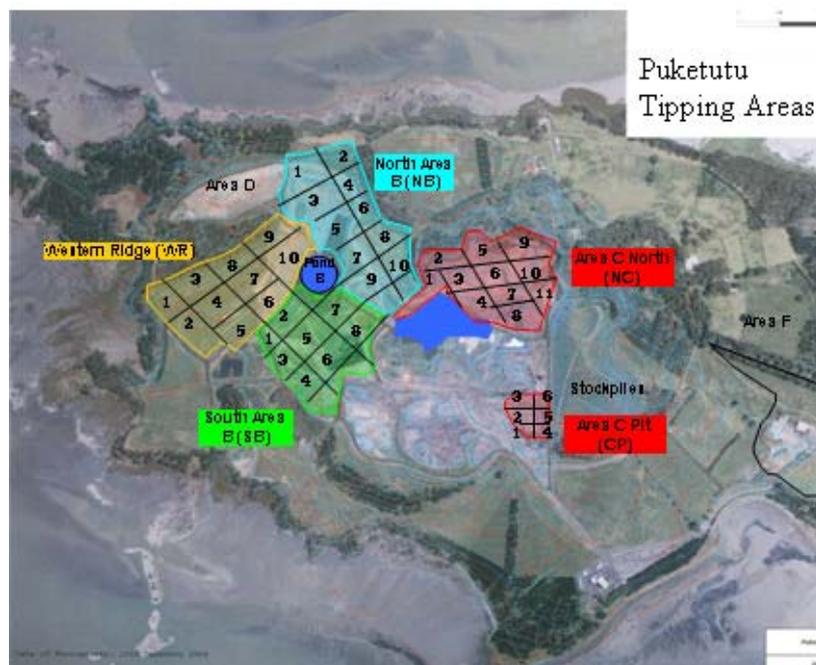
The cleanfill has been divided into approximately 50m square areas which are marked on a map and allocated a grid reference as shown in Figure 10 below. The Fill inspector works with the Environmental Coordinator to ensure that a tally is kept each day so the tip location of incoming fill can be tracked. This is a contingency measure in case it was found that contaminated fill made its way into the cleanfill and remedial action was required.

Figure 10: Puketutu tipping area grid references,

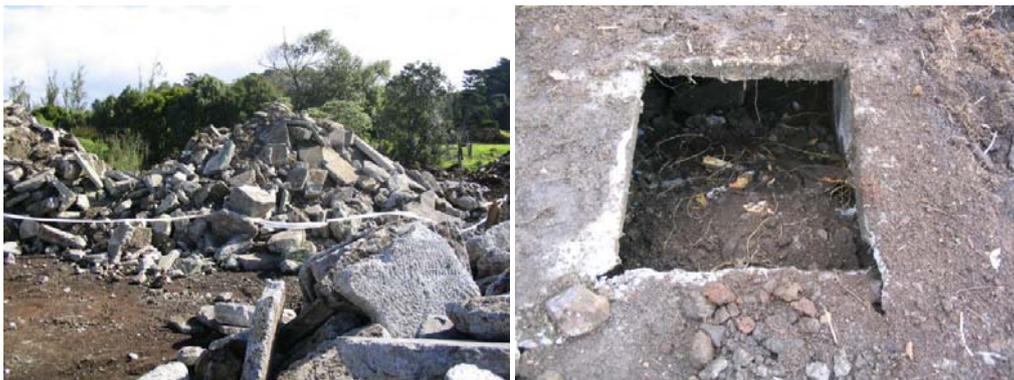
This strategy provided the most efficient means of ensuring the highly contaminated material was appropriately disposed of, whilst enabling cost efficiencies (reduced transport and landfill charges) for dealing with the mildly contaminated material that did not pose a significant risk to the environment and avoid using valuable space at a MWL. Figure 11 below shows contaminated concrete ready to be carted to landfill and one of the in ground CCA holding tanks uncovered.

Figure 11: Contaminated concrete ready to be carted to landfill and one of the in ground CCA holding tanks uncovered.

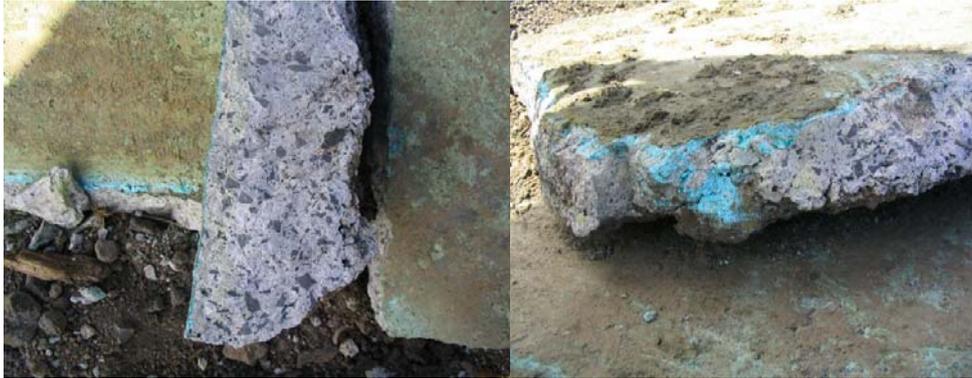
Following staff inductions, in accordance with a site specific Health and Safety Plan, excavation works commenced in March 2008 with the concrete drip pad being broken up. The bright green and yellow Cr stained concrete was subsequently removed to landfill (approx 834t). Some of the brightly stained concrete is shown in Figure 12 below.

Figure 12: Some of visible signs of Copper contamination in the concrete from the sawmill drip pad.

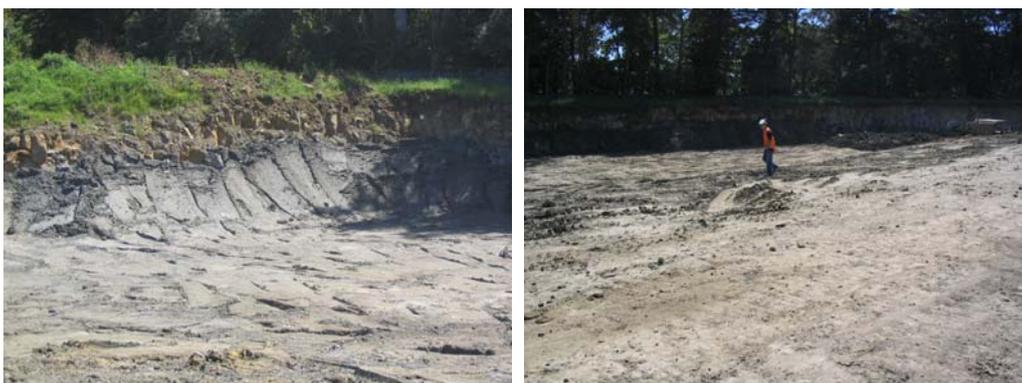
A clay containment cell was constructed with low permeability compacted clay received from a single source. The constructed base and walls of the clay cell are shown in Figure 13 below. Mildly contaminated material from the sawmill area was excavated and placed in the clay cell and validation sampling of the sawmill area was completed. The use of the hand held XRF was of great assistance in this process as real time analysis could be obtained as excavations progressed. This did not replace the need for lab analysed samples but did help with targeting the remediation approach to hot spot areas and determining the boundary of these areas.

Figure 13: The clay cell which was constructed on site to contain mildly contaminated material.

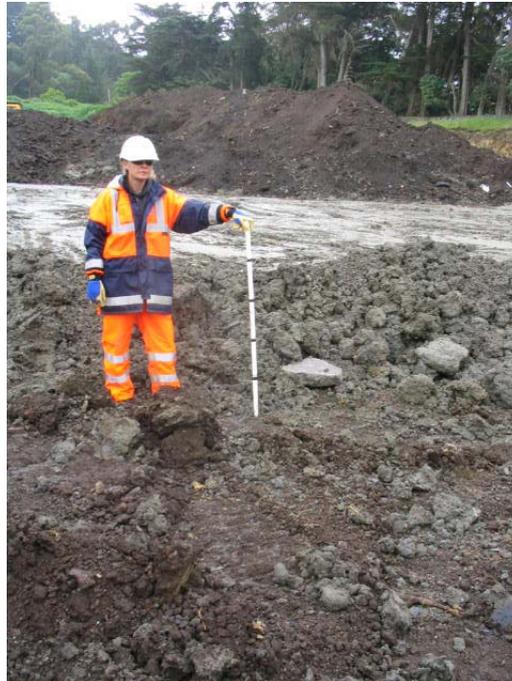
will be finalised before backfilling of the void to reinstate the area to former ground levels using fill imported onto site from the cleanfill process. Imported soil will be subject to normal quality control processes to ensure the material used is appropriate for the future land use. Figure 14 below shows an operator measuring the depth of the stripping to ensure mildly contaminated material has been removed to the correct depth.

Figure 14: Ensuring mildly contaminated material is excavated to the correct depth.
