LAND DAMAGE ASSESSMENT LIQUEFACTION & LATERAL SPREAD

**Presented by Murray Discombe
Fraser Thomas Ltd, Auckland
at the Annual QuarryNZ Conference
Wellington, New Zealand
July 2012**

Land Damage Assessment

Liquefaction & Lateral Spread

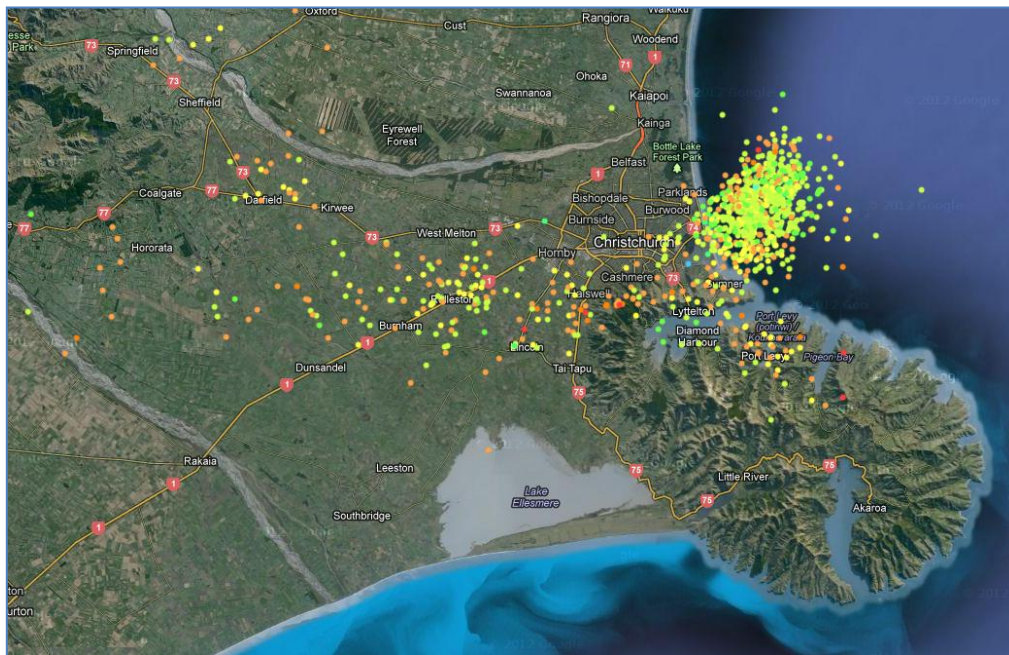
There have been more than 10,600 earthquakes since Sep 2010, with 1059 shown in the slide below (230 days since 23/12/2011). There is a distinct pattern, with the majority occurring in a line across the city extending out into Pegasus Bay in a north-easterly direction. Most are less than 10km depth (yellow dots).

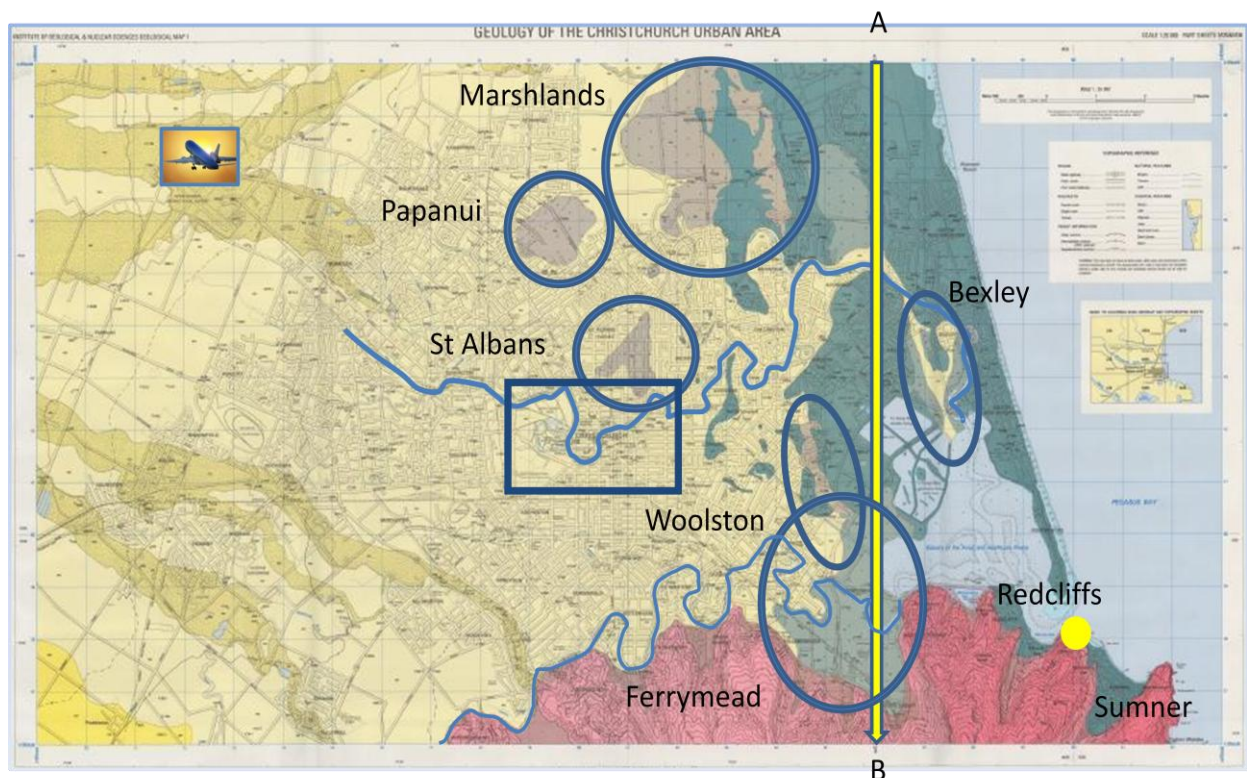
This map depicts the geology of the Christchurch urban area. There are a number of areas featured which will be addressed later in the paper.

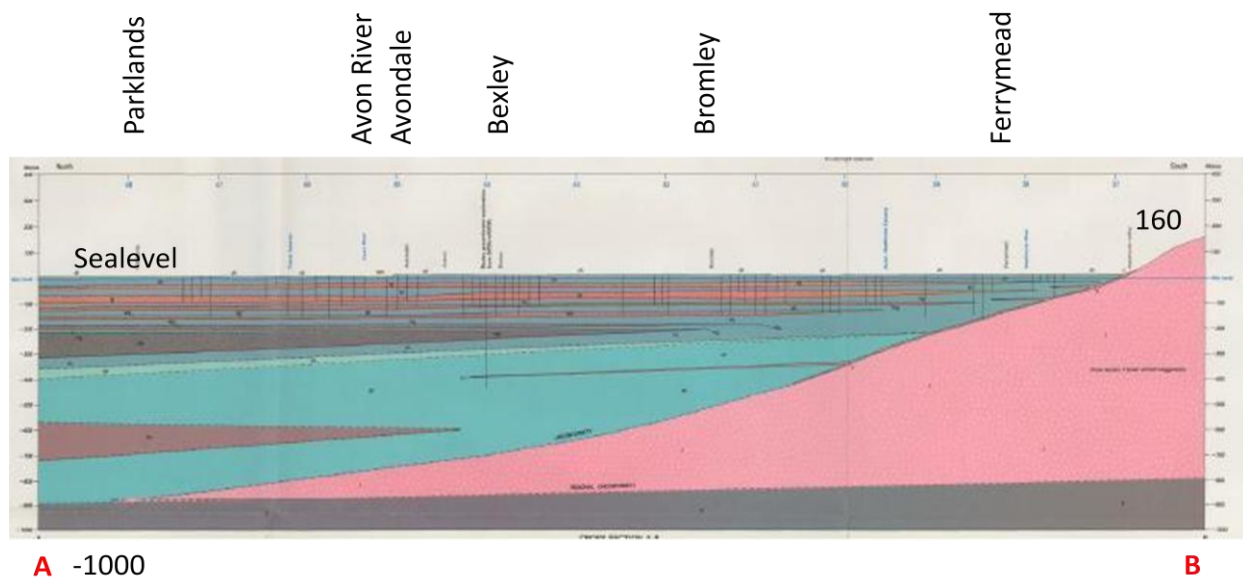
The cross section AB shows the Port Hills at approx 160m above sea-level. The geology is typically thin layers of deposited sands, gravels and silts, interspersed with some volcanic material comprising the following forms.

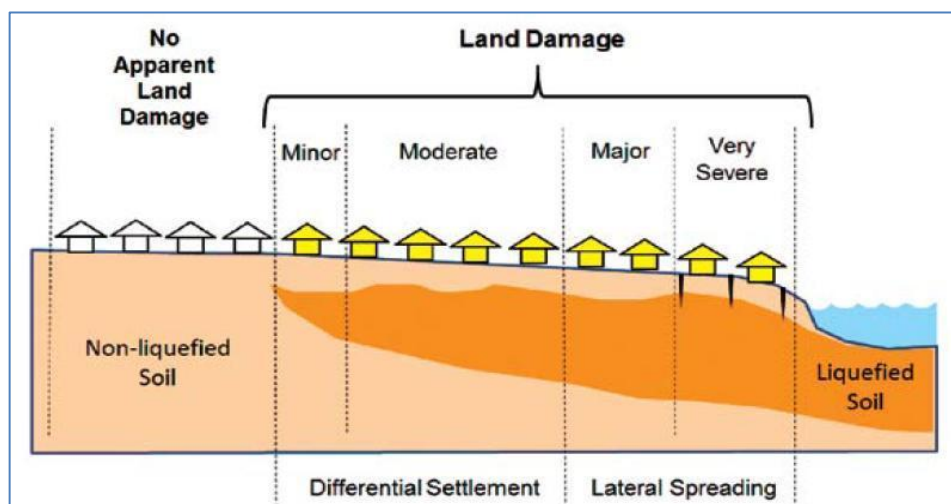
This diagram, courtesy of Department of Building & Housing indicates where lateral spreading and differential settlement is likely to occur. The extent of lateral spreading is greatest where the land is immediately adjacent to a waterway – creek, stream, river, estuary etc.

Earthquakes induce increased pore pressure in soils commencing the liquefaction process where soils containing fine silts especially silty sand trigger land to slide towards the water.

Lateral spreading is characterised by horizontal displacement creating cracks / fissures in ground generally parallel to a stream, river or estuary. They also form in areas adjacent to old river beds or edges of drained swamps. There is usually a vertical offset in ground level each side of the spread crack. The effects can be significant, often affecting foundations and inducing tilt settlements in dwellings and buildings.
