# SAFETY ALERT

## Light vehicle drives off bench in open cut mine

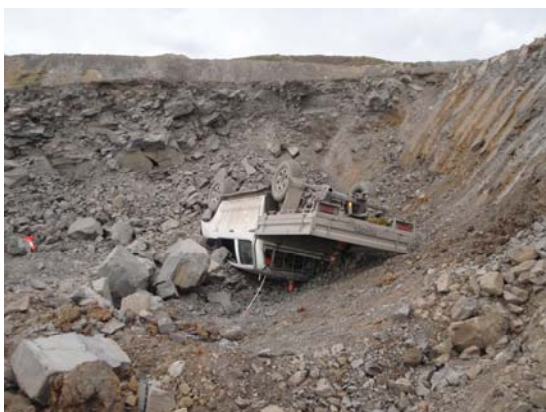
While exiting the bench he drove over a 4.5 metre low wall and the vehicle landed on its roof. The operator had been on the bench for approximately one minute.

The light vehicle at rest after being driven off the bench (left); and a view at the top of the bench from which the vehicle fell (right).

1. All personnel should notify the relevant mining official when they are entering a work area.
2. All operators should receive positive communication from the mining supervisor and any machinery operator in the work area they are entering.
3. Operators should be familiar with their work environment before working in the area.
4. An inspection should be undertaken to ensure that surface transport management plan requirements are in place. The surface transport management plan should be reviewed and, if found deficient, should be strengthened.
5. All operators should wear seat belts while operating machinery.

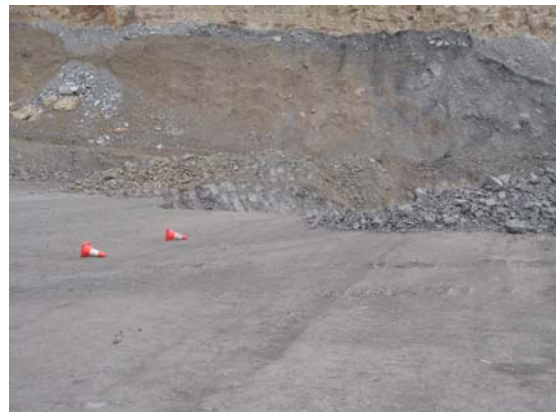
The operator confused a small amount of material on the bench for the windrow of the ramp. The ramp windrow finished at the same point as the edge of the top of the low wall.

The top of the ramp was not clearly delineated. The edge of the low wall was not delineated. There was no barrier to warn the operator he was approaching the edge of the ramp.
