Safety alert 232
Published 25 August 2009

Vehicle collisions - how long before it's really bad?

Mine Type: All surface mines

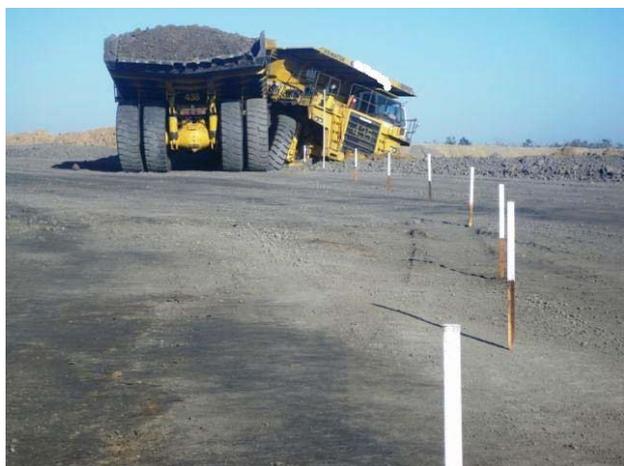
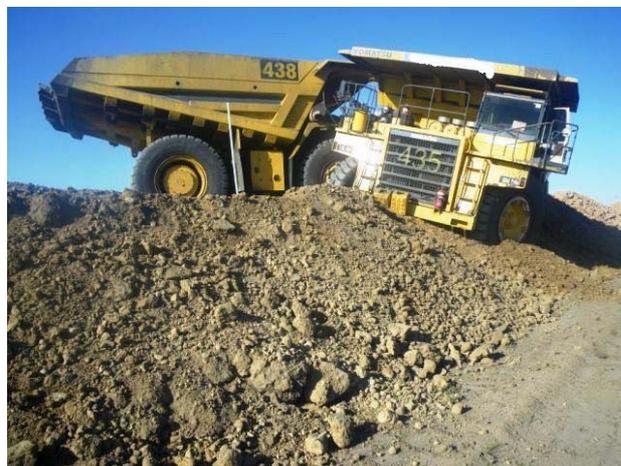
Incident: On the first nightshift of the tour, at 4.30am, an operator of a loaded rear dump truck fell asleep at the wheel on entering a left hand bend, crossed the lanes and collided with an approaching empty rear dump truck. The operator of the empty truck saw what was happening, tried to avoid the collision, and also attempted communication on the 2-way radio without success. Fortunately there were no injuries.

- (1) Without prejudicing the mine's investigation, an examination of the photographs might lead to the conclusion that the general environment didn't present any particular difficulties. It is fortunate that:
 - both trucks were left hand drive
 - a light vehicle was not involved
 - the empty truck did not roll.
- (2) The mine gives credit to the operator for admitting falling asleep and therefore assisting the investigation process.
- (3) **Hard Barriers**
In April 2008, Safety Alert 194 drew attention to a probable head on collision between two rear dump trucks, when a loaded truck lost control but was stopped by a substantial centre berm dividing the haul road. Industry was challenged on the potential use of hard barriers and two comments from that safety alert are repeated below:

A mine's risk management process must drive regular review of operational procedures to identify any changes in circumstances, such as the availability of other control options, new technology or innovations. This continuous improvement process is another fundamental of the mining safety and health legislation, and a means of ensuring that risk is maintained '*as low as reasonably achievable*'.
