Safety Alert

Mines Inspectorate—Surface metalliferous mines and quarries

Safety Alert No. 284 | 18 January 2012

Severe acid burns to foot as drain collapses

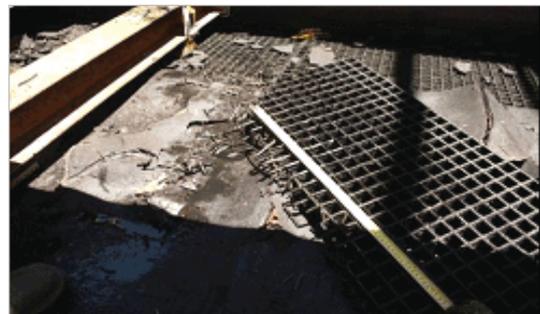
- acid in the drain came from a leaking tank pipe flange, with the sump pump not operating at the time
- over time, the acid damaged the concrete substrate and the integrity of the fibreglass grid mesh
- the worker's boot type allowed acid ingress.

Condition of the fibreglass grid mesh

1. Ensure that drains are included in structural integrity inspections.
2. Inspect the integrity of **all** drains, including the concrete substrate, particularly those drains in wet, corrosive or chemical storage areas.
3. Check the compatibility of the grid mesh material with substances contained in chemical storage compounds.
4. Check all requirements for PPE, and entry into chemical storage areas, and ensure that these requirements are adequate.
