Fatality #7 - April 18, 2008
Machinery - Underground - Pennsylvania
Rosebud Mining Company - Little Toby Mine

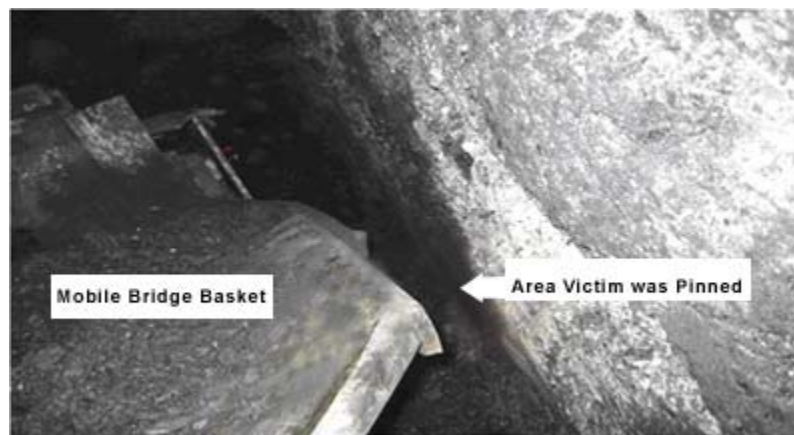
COAL MINE FATALITY - On Friday, April 18, 2008, a 43-year old continuous miner operator with 3½ years experience was fatally injured while operating a continuous miner with an attached mobile bridge conveyor system. As the victim was positioning the continuous miner in a crosscut turning right, the inby mobile bridge operator felt an unusual bouncing of the bridge and failed to get a radio response from the miner operator. The bridge operator shut the system down using the emergency stop switch and crawled toward the face and discovered the victim pinned between the basket of the bridge and the left rib.

- Frequently review, retrain, and discuss avoiding the **"RED ZONE"** areas when operating or working near a remote controlled continuous mining machine.
- Follow established safe work practices and provide periodic training along with checks to ensure that the safe work practices have been properly implemented.
- Pursue new technology such as proximity detection to protect personnel and eliminate accidents of this type.
- Minimize the number of miners working or traveling near operating systems and maintain an effective means of communications between miners and system operators.
