**Fatality #20 - October 17, 2008**  
**Fall of Roof/Back - Georgia - Limestone (Crushed and Broken)**  
**O-N Minerals (Filler Products) Company - Marble Hill Mine**

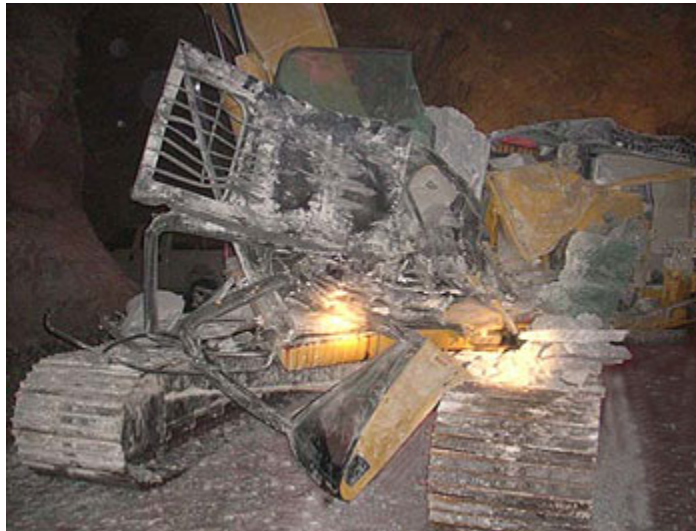
**METAL/NONMETAL MINE FATALITY** - On October 17, 2008, a 45 year-old scaler operator with 8 years of experience was fatally injured at an underground stone mine. He was inside the cab operating a track mounted excavator, with a scaling attachment, when a rock fall occurred. A rock, about 13' wide x 26' long x 4½' thick, fell from the back. Rescuers recovered the victim about 7 hours after the rock fell.

- Examine and test ground conditions in areas where work is to be performed prior to work commencing and as ground conditions warrant during the shift.
- Be alert to any change of ground conditions.
- Identify and scale loose ground from a location which will not expose persons to falling material.
- Use scaling equipment with sufficient reach to prevent persons from exposure to falling material.
- Take down or support ground that creates a hazard to persons before performing other work or travel in the affected area.
- When ground conditions create a hazard to persons, install ground support before other work is permitted in the affected area.
- Design and use mining methods that will maintain stability and control the ground in places where persons work or travel.
